**Characteristics of losses of geological disasters and major disaster types in Liangshan Prefecture, Sichuan Province**

DOI: 10.16031/j.cnki.issn.1003-8035.202305029

## 四川凉山州地质灾害灾情特征与主要致灾类型

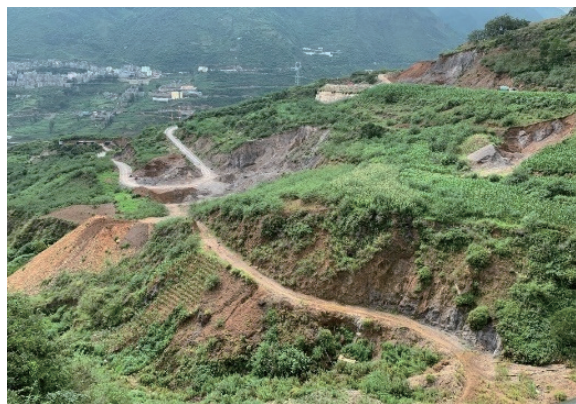
人类工程活动对原有地质环境的改造,是诱发凉山州地质灾害的重要因素之一。道路建设、切坡建房等人类活动(图 1—2),对边坡不合理的开挖,破坏斜坡体稳定性,在降雨、地震等诱发因素下更容易发生滑坡灾害。凉山州矿产资源丰富,矿区内废石、弃渣的不合理堆放(图 3),会造成弃渣斜坡的失稳滑动,也为矿渣型泥石流的形成提供丰富物源。

图 1 金阳县新区建设开挖形成的陡坡

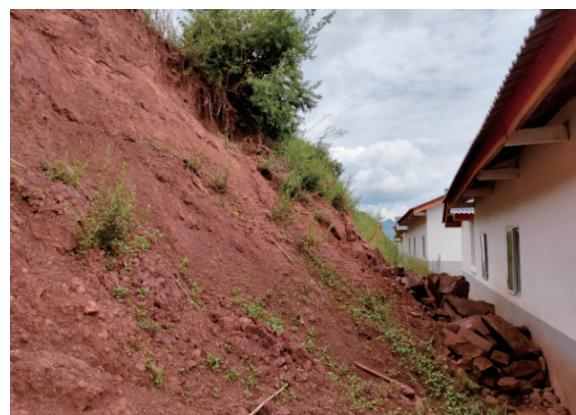
图 2 切坡建房引发的滑坡

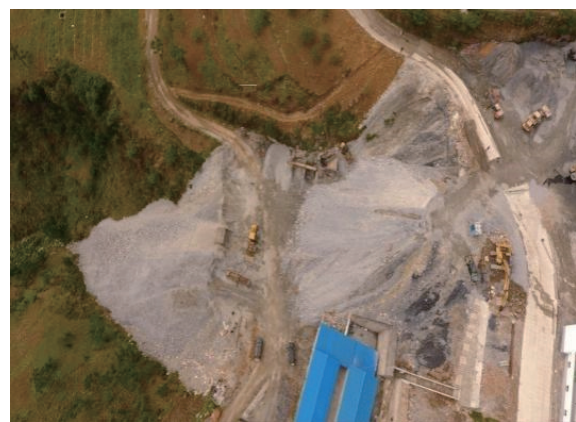
图 3 雷波县某磷矿形成的矿渣堆

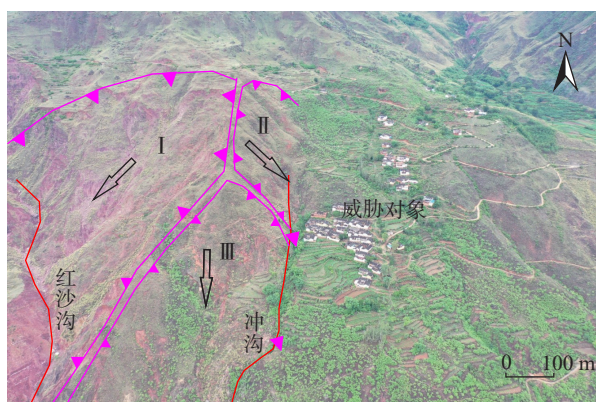
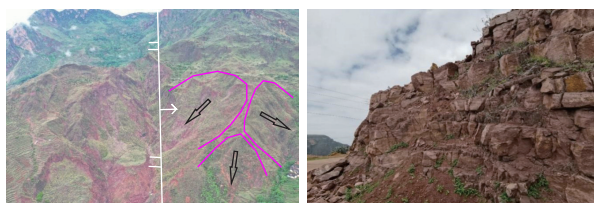
图 6 会理市新发镇铜厂村 1 组老包滑坡示意图

会理市新发镇铜厂村 1 组老包滑坡(图 6),出露岩性为第四系全新统残坡积层(Qh<sup>el+dl</sup>)碎石土,下覆基岩

为下震旦统澄江组(Z<sub>1c</sub>)粗粒长石石英砂岩夹紫红色含砾砂泥岩,岩层产状 185°∠35°,岩体易风化破碎,遇水极易软化解体。滑坡附近有一条近南北走向逆断层通过,大致沿红沙沟延伸。老包滑坡所在红沙沟位置,均为断层破碎带,岩体异常破碎,地质条件脆弱,断层是滑坡形成的主要原因之一。同时,滑坡区地层遇水易软化解体,降雨入渗使岩土体饱水,造成自重加大和软弱结构面润滑,加之良好的临空面,最终在陡坡段形成滑坡。

(a) 滑坡全貌

(b) 断层大致走向

(c) 断层破碎带

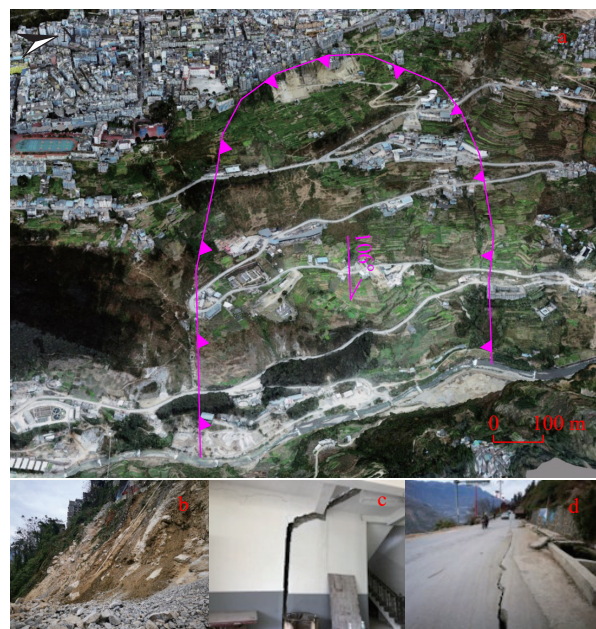
图 7 金阳县天地坝镇老营盘村城北滑坡

金阳县天地坝镇老营盘村城北滑坡,顺层牵引式深层特大型滑坡(图 7)。出露地层为含碎石粉质黏土、碎石土。主滑方向  $106^\circ$ ,平均宽度 570 m,纵向长约 630 m,滑体平均厚度 35 m,总体积约  $1.253 \times 10^6 \text{ m}^3$ ,滑坡平面形态呈舌型,滑体物质组成主要为碎石土、角砾土,局部夹块石、黏土,由于滑坡年代久远,滑体物质胶结良好。下覆基岩主要为下奥陶统湄潭组( $O_1m$ )页岩、灰岩及上寒武统二道水组( $\epsilon_3e$ )白云岩。由于金阳河的不断切割,致使前缘临空面不断加大,最终导致古滑坡的发生,近年来古滑坡未出现整体变形迹象。但由于人类工程活动的加剧,新建房屋大量填方、生活污水排放、降雨入渗等原因,古滑坡体局部区域出现了变形和次级滑动,滑坡左侧中部区域变形破坏较为强烈,地表可见发育有多条明显拉裂缝,房屋变形破坏较严重,形成体积约  $1.368 \times 10^6 \text{ m}^3$  复活体。

注: a 为滑坡全貌; b 为滑坡后壁; c、d 为复活体变形特征。

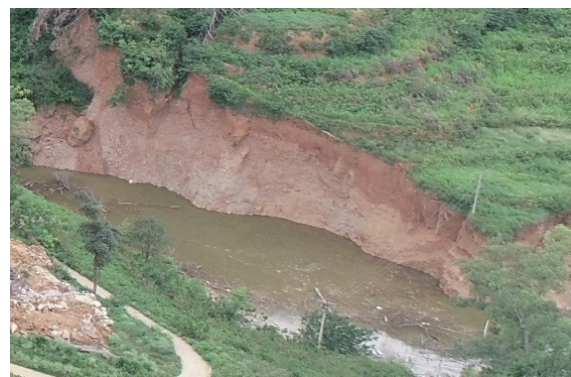
受库水位消落带影响,斜坡坡脚常发生滑塌现象,进而影响坡体稳定性,如木里县锦屏库区尾库段的后所乡、列瓦镇一带,发育有 23 处库岸型滑坡;布拖县金沙江沿岸合并—牛角湾一带,地处溪洛渡库区库尾,受库水位影响发育有大滩滑坡,麻地湾滑坡,贾沙田滑坡等库岸型滑坡;宁南县白鹤滩电站 2021 年水位抬升后,发育有 17 处塌岸隐患,多数为土质边坡(图 8)。

图 8 白鹤滩电站边坡前缘塌岸

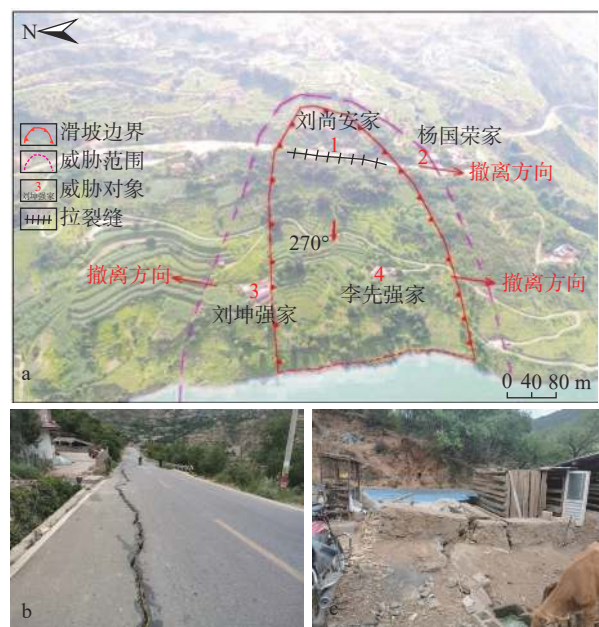
木里县瓦厂镇纳子店村店扎组滑坡位于木里县瓦厂镇纳子店村店扎组(图 9),木里河左岸。平面形态呈舌形,坡面形态呈折线形,相对高差约 120 m,宽 160 m,长 330 m,主滑方向  $270^\circ$ ,平均厚 10.0 m,体积约为  $52.8 \times$

10<sup>4</sup> m<sup>3</sup>, 属中型土质滑坡。滑体物质主要为全新统的滑坡堆积(Qh<sup>del</sup>)的碎石土, 下覆基岩为下奥陶统组瓦厂组(O<sub>1w</sub>)青灰色砂岩。受木里河立州水电站蓄水影响, 在水位升降及斜坡土体饱水等作用下滑坡出现变形, 2019、2020 两年变形较剧烈, 后部 G227 国道路面出现拉裂、下错, 房屋墙体出现裂缝。

图 9 木里县瓦厂镇纳子店村店扎组滑坡  
Fig. 9 Diancha Formation landslide in Nazidian Village, Wuchang Town, Muli County  
注: a 为全貌; b 为滑坡后部裂缝; c 为滑坡后部垮塌猪圈。

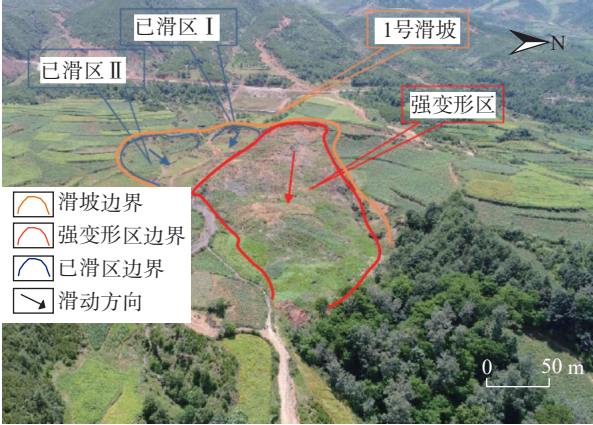
煤系地层主要发育在凉山州南部的中低山区, 上三叠统白果湾组、须家河组、宝顶组等地层为主要产煤地层。布拖县勒吉村 4 组约坡吉乃滑坡, 位于布拖县北部(图 10), 为一处沿基覆界面滑动的中型土质滑坡。20 世纪 80 年代, 滑坡前缘底部发现褐煤层, 每到冬季当地村民集中开挖褐煤取暖, 到 2004 年形成一高 5~8 m 近垂直人工边坡, 2004 年受强降雨影响, 该人工边坡开始出现滑塌现象, 边坡后缘出现贯通拉裂缝, 2010 年 7 月滑坡前缘整体垮塌, 同年 9 月发生整体滑动。滑坡可分为强变形区、已滑区 I 区、已滑区 II 区。强变形区微地貌主要为陡坡、陡坎, 横宽 95~130 m, 纵长约 270 m, 主滑方向 89°, 面积约 2.45×10<sup>4</sup> m<sup>2</sup>, 平均厚约 12 m, 总体积约 29.4×10<sup>4</sup> m<sup>3</sup>, 坡体基本解体, 剖面形态呈三级平台, 滑坡后壁坡度近垂直, 相对高差约 12 m, 2015—2017 年向右前侧滑动 7~9 m; 已滑区 I 区位于 1 号滑坡体中右侧, 横宽约 60 m, 纵向长约 55 m, 主滑

方向 99°后缘滑壁陡峭, 中前部形成相对较缓的坡体, 形成“上陡下缓”形态, 体积约 1.2×10<sup>4</sup> m<sup>3</sup>; 已滑区 II 区位于 1 号滑坡体右后侧, 横向宽 40~50 m, 纵向长 60~70 m, 主滑方向 59°, 滑坡后壁高差约 1.5 m, 体积约 2.57×10<sup>4</sup> m<sup>3</sup>。坡体含碎石黏土, 下覆基岩为昔格达组砂质泥岩。

图 10 布拖县勒吉村 4 组约坡吉乃滑坡示意图  
Fig. 10 Schematic diagram of Yuepo Jinai landslide in Group 4, Leji Village, Butuo County

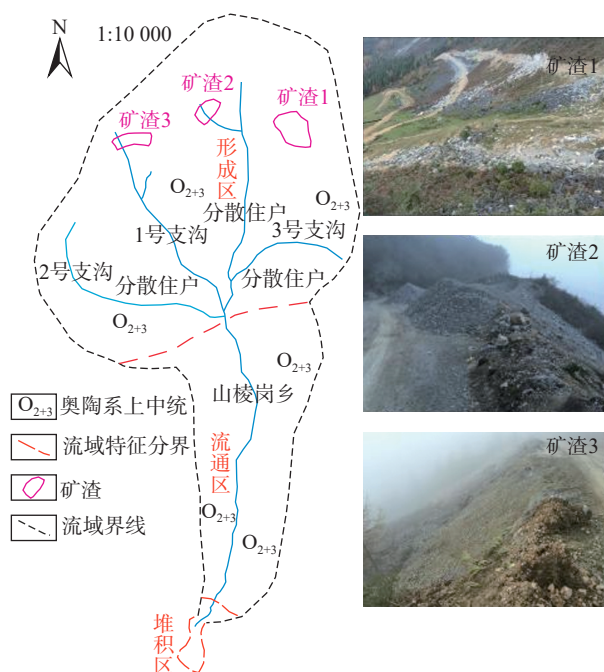
凉山州矿产资源丰富, 矿山开采的矿渣、剥离废石、尾砂等废物, 不合理的堆放, 为泥石流灾害提供了丰富物源。雷波县西苏角河流域日格尔泥石流, 位于山棱岗乡田坝村 3、6 组, 沟口位于西苏角河(图 11)。在 1972 年、2013 年和 2014 年规模性暴发过, 属于暴雨激发的中—高频中型稀性泥石流。单次冲淤堆积体积约 0.72×10<sup>4</sup> m<sup>3</sup>, 现沟内可参与泥石流活动的固体物源储量达 37.13×10<sup>4</sup> m<sup>3</sup>, 2016 年对该泥石流进行了排导槽治理。沟域高程差约为 1 800 m, 流域面积 16.39 km<sup>2</sup>, 主沟沟道长 6.92 km, 主沟呈“U”字型。由四条支沟交汇形成, 汇水条件好, 支沟多呈狭窄“V”字型, 暴雨形成的地表径流是引发泥石流的主要水源。在流域的中上部为铅锌矿私挖开采地, 采矿分选后大量的矸石沿沟道、公路堆积, 成为了该沟的重要物源, 现该私挖矿场已经关闭, 其他物源来自于沟床侵蚀物源(沟床内松散堆积体)及坡面侵蚀物源。

图 11 日格尔泥石流示意图

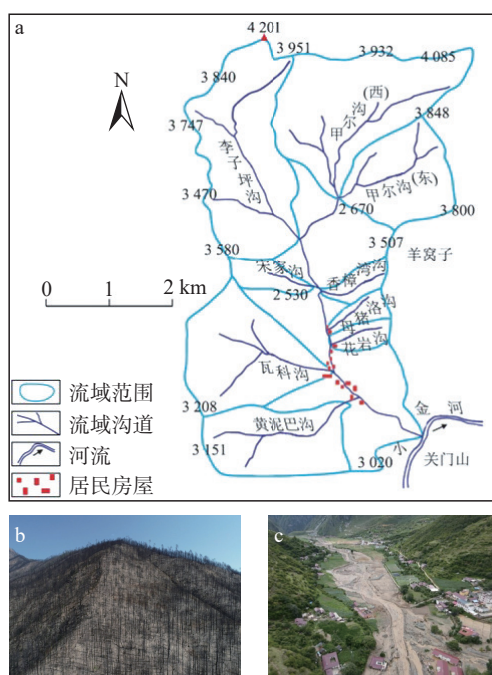
图 12 木里县项脚乡项脚沟泥石流示意图

木里县项脚乡项脚沟流域火后泥石流就是此类泥石流的典型(图 12)。2020 年 3 月 28 日, 木里县项脚乡及其毗邻乡镇发生森林火灾, 其中项脚乡项脚沟流域的中、上部火灾导致植被遭受严重破坏, 过火面积约 37.97 km<sup>2</sup>, 中度及重度火烈度区面积占比 65.81%。自 6 月 9 日山顶附近局地短时强降雨激发甲尔沟暴发火后泥石流灾害以来, 项脚沟主沟及宋家沟、香樟湾沟、母猪洛沟、花岩沟、黄泥巴沟等多条支沟于 6 月、7 月先后 7 次发生不等规模火后泥石流, 冲出固体物质 10 余万方, 导致沟口 22 户居民建筑物被淤埋, 直接经济损失超 2 600 万元。2021 年 7 月 5 日, 短时强降雨导致项脚沟流域 7 条支沟再次相继发生泥石流灾害, 携带大量粗大树木, 冲出沟口物源达  $1.62 \times 10^6$  m<sup>3</sup>, 沟道内分布有大量漂石, 岩性以灰岩为主, 其中最大颗粒直径为 3.2 m × 3.1 m × 1.9 m。灾害造成 186 间房屋和乡道 2 km 受损, 撤离避险 251 户 1 042 人, 无人员伤亡。

项脚沟流域面积 77.12 km<sup>2</sup>, 主沟长 14.95 km, 平均纵比降为 110‰, 流域最高海拔 4 130 m, 沟口最低海拔 1 820 m, 最大高差 2 310 m, 主沟沟道以宽“U”型谷为

注: a 为流域平面图; b 为过火区坡面侵蚀物源; c 为主沟淤积段。

主。中上游呈“树枝状”水系, 下游呈“掌状”水系, 各级支流共计 30 余条, 其中一级支沟 13 条。支沟多以“V”型谷为主, 山体平均坡度多在 40°以上, 基岩出露较多。地层以三叠系西康群及上二叠统地层为主, 岩性主要为变质砂岩、砂板岩、板岩、大理岩及结晶灰岩夹层、变质玄武岩, 及少量千枚岩。流域内不良地质现象发育, 松散固体物质  $2.2164 \times 10^4$  m<sup>3</sup>, 动储量为  $2.928 \times 10^6$  m<sup>3</sup>, 主要为早期崩滑堆积物源、坡面侵蚀物源、历史泥石流沟道堆积物源及火灾形成的灰烬及土壤结构扰动层等物源, 火烧区物源主要分布于沟域顶部。

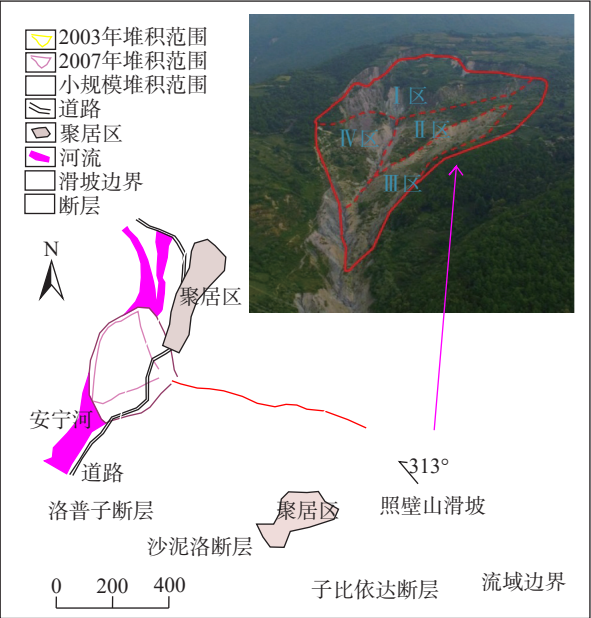
冕宁县照壁山滑坡位于冷渍沟上游(图 13), 滑坡呈“圈椅状”, 主滑方向为 313°, 滑坡区地层主要为早震旦世苏雄组一段(Z<sub>1</sub>S<sub>1</sub>)变流纹、变英安岩, 三叠系白果湾群(T<sub>3</sub>bg)砂岩、页岩, 以及第四系残坡积物。大规模发生于 2000 年 7 月 18 日, 滑坡发生时体积约 337 ×

10<sup>4</sup> m<sup>3</sup>,形成的碎屑流冲出冷渍沟口约 30×10<sup>4</sup> m<sup>3</sup>,堵塞安宁河河道;剩余滑坡体堆积于冷渍沟中,此后雨季冷渍沟均发生规模不等的泥石流。2003 年 7 月 19 日,冕宁县遭遇 50 年一遇暴雨(日降雨量达 218.6 mm),冷渍沟暴发大规模泥石流,约 30×10<sup>4</sup> m<sup>3</sup> 固体物质冲出沟口,造成堆积扇上 1 人死亡,3 辆汽车被掩埋,同时冲入安宁河造成河道堵塞,河水淤高翻越右岸防护堤,冲毁右岸部分房屋、耕地。2007 年 8 月 7 日,冷渍沟再次暴发泥石流堵塞安宁河河道。2007 年 8 月 7 日,冷渍沟再次暴发泥石流堵塞安宁河河道。

图 13 冕宁县照壁山滑坡-泥石流链式灾害示意图  
Fig. 13 Schematic diagram of Zhaobi Mountain landslide-debris flow chain disaster in Mianning County
