易守勇, 贾龙, 韩庆定, 等. 佛山市富湾冲孔桩施工引发岩溶地面塌陷机理分析[J]. 中国岩溶, 2024, 43(5): 1144-1155.

# 佛山市富湾冲孔桩施工引发岩溶地面塌陷机理分析

**摘要:** 在岩溶区冲孔桩施工处置不当, 往往会引起严重的地面塌陷。文章针对佛山富湾冲孔桩施工引发的岩溶地面塌陷事件, 在野外调查和测量的基础上, 采用钻探和物探等方法, 对岩溶地面塌陷地质条件及其形成机理进行研究。研究表明其成因主要有: ①基岩砾状灰岩纯度较高, 地质构造作用强烈, 溶洞极为发育。②第四系底部广泛分布含泥质砂层和残积土层, 且砂层分布广、厚度大。③地下水位埋深浅、与地表水力联系强、位于地下水径流通道上, 紧靠西江, 地下水作用强烈。④受人类工程活动影响, 冲孔桩施工振动作用直接引发地面塌陷。其形成过程可归纳为裂隙期→溶洞期→土洞期→塌陷期→群塌期等五个阶段。因此, 在岩溶区冲孔桩施工之前, 应开展岩溶专项勘查, 针对性制定施工方案, 在揭穿岩溶通道过程中, 特别要加强对岩溶地下水的监测, 以保证工程施工和人员安全。

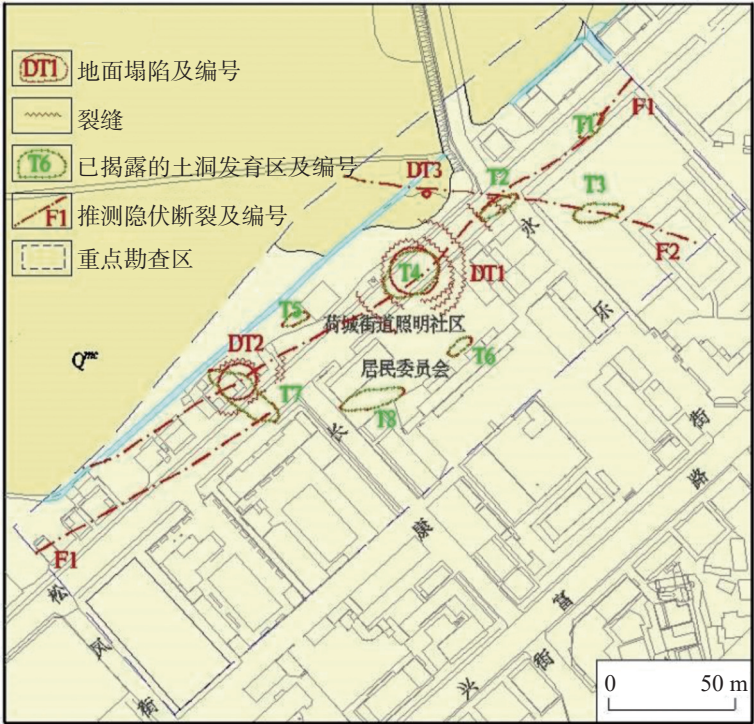
组断裂走向北东、另一组断裂走向东西(图 5), 其中, ①北东向隐伏断裂(F1): 推测破碎带走向约 NE45°~50°, 宽度 80 m 以上, 断距不大, 断裂性质及近代活动性不明; ②东西向隐伏断裂(F2): 钻探揭露岩芯破碎, 孔中漏水, 溶洞具 2~4 层多层特征。

图 5 土洞发育分布图  
Fig. 5 Development distribution of soil caves

洞率高达 21.60%, 见图 5、表 4。其中有 7 个钻孔揭露的土洞发育在第四系最底层中砂与微风化砾状灰岩之间; 1 个钻孔揭露的土洞发育于第四系最底层中砂顶部。8 个土洞中有 7 个呈无充填状态, 1 个呈半

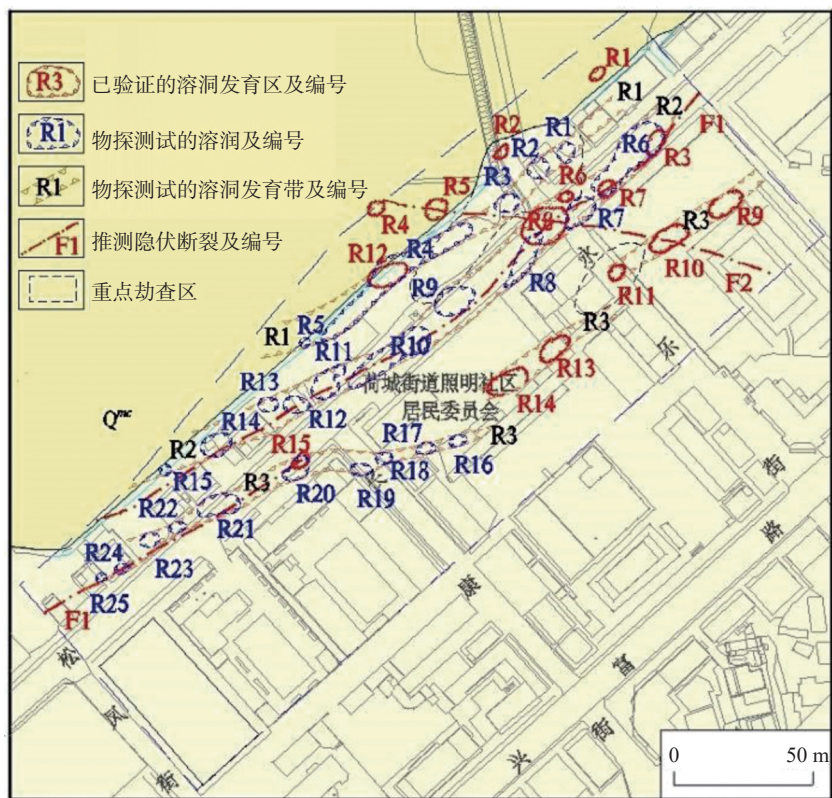
2~12 m, 大部分呈无充填状态 (充水), 极少量呈半充填状态。由图 7 可知, 溶洞与土洞发育分布基本一致, 亦为北东向断裂所控制。

图7 溶洞发育分布图
