张钟远, 谭磊, 赵鹏, 等. 三峡库区瞿塘峡至巫峡段消落带灰岩质量劣化特征[J]. 中国岩溶, 2025, 44(2): 250-260.

# 三峡库区瞿塘峡至巫峡段消落带灰岩质量劣化特征

**摘要:** 文章以三峡库区瞿塘峡至巫峡段消落带灰岩为研究对象, 基于地质调查、回弹试验、声波波速测试、干湿循环试验和CT扫描等多源方法与技术, 开展岩体(岩石)质量劣化、强度变化、微观劣化规律分析, 系统研究该类岩体劣化特征。结果表明: 三峡库区瞿塘峡至巫峡段灰岩劣化现象主要有裂隙扩展与新生、溶蚀/潜蚀和机械侵蚀3种类型; 经历库水位升降周期后, 库水位变动带岩体强度降低明显, 且有浅表层劣化快、深层劣化较慢的规律; 干湿循环条件下结构面、裂隙等缺陷的存在是岸坡岩体劣化的控制性因素; 应力对裂隙的扩展作用要远大于溶蚀作用, 岩体遭受劣化的主要机制是水流的溶蚀作用与应力断裂, 其中应力是裂隙扩展的主要影响因素; 岩石劣化过程中裂隙动态演化过程依次为表面孔隙增多, 裂隙逐渐由表及里扩展延伸, 岩样内部孔隙明显大幅度增多, 裂隙结构面再扩展并不断增加其孔隙度使得裂隙显化愈加明显。

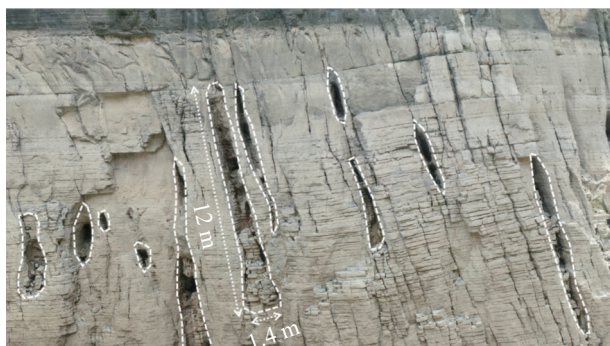
图3 箭穿洞段溶蚀/潜蚀劣化现象

(2)溶蚀/潜蚀 指消落区岩体中溶沟、溶槽、溶隙或孔洞明显变多或变大,胶结物溶解后被搬运,导致岩体缺陷明显增多的现象。以箭穿洞段为例,其地层为大冶组四段浅灰色薄层状泥质灰岩,消落区纵向状裂隙明显多于非消落区,沿裂隙方向发育大量的长条状溶蚀裂缝和孔洞。溶蚀裂缝长2.0~12.0 m,宽0.5~1.0 m,深度0.1~0.6 m。溶蚀裂缝主要沿构造裂隙发育,与岩体卸荷、构造切割相耦合,形成控制岸坡局部岩体稳定性的关键因素。调查发现纯质的灰岩反而岩溶发育程度较低,泥质含量较重

的泥质灰岩溶蚀迹象反而较强烈,溶孔及溶蚀裂缝的可溶物质被溶解带走,岩体完整性受到明显破坏(图3)。

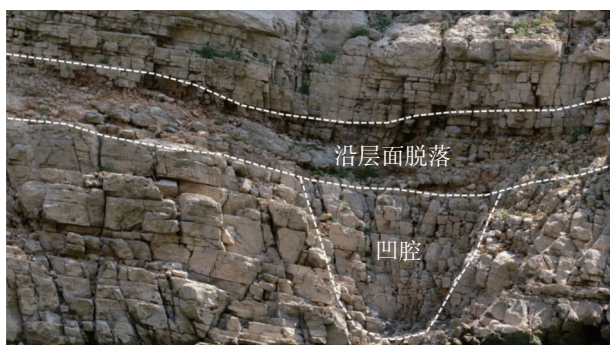
图4 大宁河段机械侵蚀劣化现象

(3)机械侵蚀 指水流机械力侵蚀造成了消落区中碎裂岩体发生带状侵蚀、凹腔状侵蚀、侧向侵蚀或坡面侵蚀。以三峡库区主要支流大宁河段为例,地层为三叠系下统嘉陵江组三段灰色薄层至中厚层状泥质灰岩,节理裂隙发育,裂隙面结合程度差,局部充填碎石,受层面裂隙及两组构造裂隙切割,岩体整体较破碎。在江水动力作用下,裂隙间胶结物被带走,块体与母岩脱开后多沿外倾裂隙出现翻滚、滑落。同时,在部分岩体滑塌脱落后,会形成小型凹腔,在库水动力作用下,对凹腔存在掏蚀作用,导致岩体顺层面脱落(图4)。

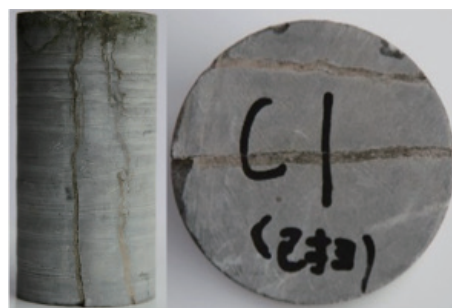
图 13 试验岩样

以三峡库区剪刀峰岸坡灰岩岩体作为研究对象, 制作标准圆柱体岩样 ( $\phi=50$  mm,  $h=100$  mm)(图 13); 通过配置草酸溶液 ( $\text{pH}=5$ ) 来加快溶蚀作用的速率, 以模拟长期劣化水环境; 采用 nanoVoxel-3000 系列 X

射线高精度三维显微镜(CT扫描技术)和MTS815.03型压力试验系统完成试验。通过裂隙扩展试验,得到在渗流和围压条件下,裂隙的扩张演化规律。
