青海门源 M_s 6.9 地震同震破裂的隧道破坏效应与启示

The tunnel damage effects and implications of the coseismic rupture of the Menyuan M_s 6.9 Earthquake in Qinghai, China

Abstract: On January 8, 2022, a magnitude 6.9 earthquake occurred in Menyuan County, Qinghai Province, causing severe deformation and damage to the Da Liang Tunnel of the Lanzhou–Xinjiang high-speed railway, which is the first railway tunnel project broken by strike-slip earthquake in China. Through comprehensive analysis of field investigation data, InSAR surface deformation data, and monitoring results from the track control network (CPⅢ), this study delves into the characteristics of deformation and damage caused by the coseismic rupture zone of the Menyuan M_s 6.9 earthquake on the Daliang Tunnel. The results indicate that the Haiyuan Fault Zone's Lenglongling–Tuolaishan fault segment is the seismogenic fault for this earthquake, forming a coseismic surface rupture zone approximately 21.5 km long. The dominant deformation nature is left-lateral strike-slip, with a maximum left-lateral displacement of about 3.1 m. As the coseismic rupture zone intersects the Daliang Tunnel, it severely damages the tunnel structure, with the most

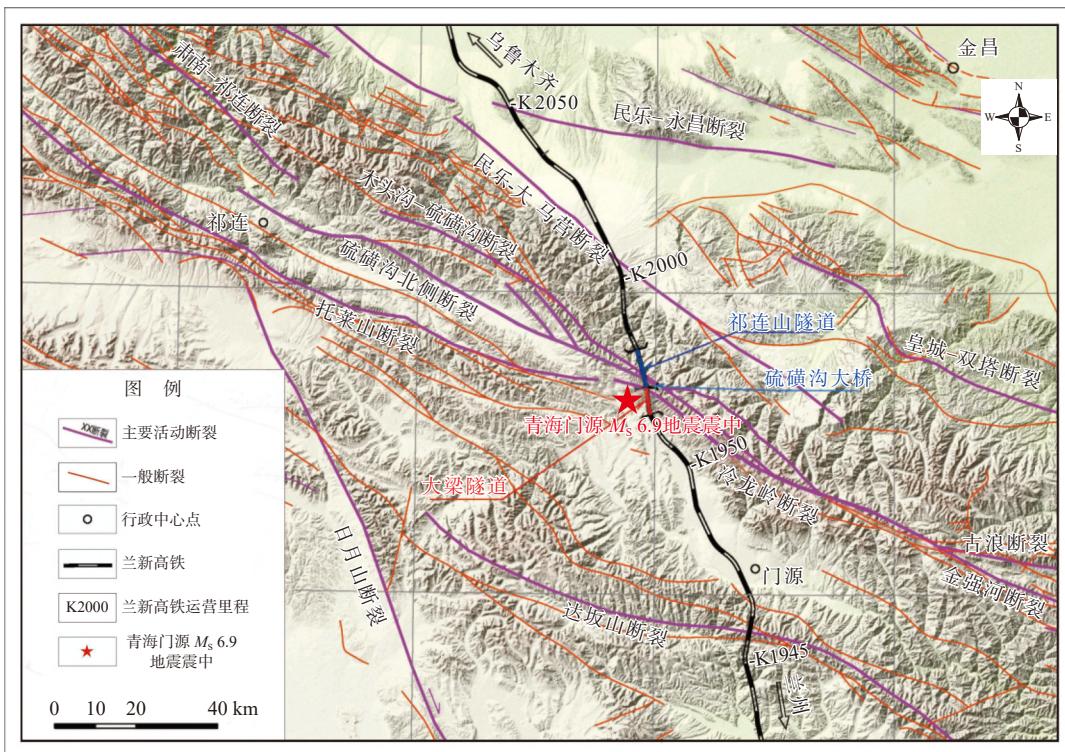
图 1 兰新高铁大梁隧道位置和区域主要活动断裂分布图

Fig. 1 Map of the location of the Daliang Tunnel and the distribution of major active faults in the area

位于青藏高原东北缘边界的北西西向—北西向海原断裂带为大梁隧道区段最主要的控震构造带, 也是调节青藏高原东北缘地壳缩短和块体向东挤出的主要活动构造带(Gaudemer et al., 1995; Tapponniere et al., 2001; 郭鹏等, 2017; 雷东宁等, 2018; 徐化超, 2019; 薛善余等, 2022)。此次门源 M_s 6.9地震的发震断裂即为海原断裂带的冷龙岭-托莱山断裂段(韩帅等, 2022; 焦其松等, 2022), 该段断裂大致沿东祁连山山脉分水岭分布, 全长约为123 km, 总体走向NW60°—80°, 为全新世活动断裂, 晚第四纪其左旋走滑速率约为15~19 mm/a(何文贵等, 2010; 张培震等, 2013; Chen et al., 2023)。兰新高铁大梁隧道穿越该断裂(图1)。

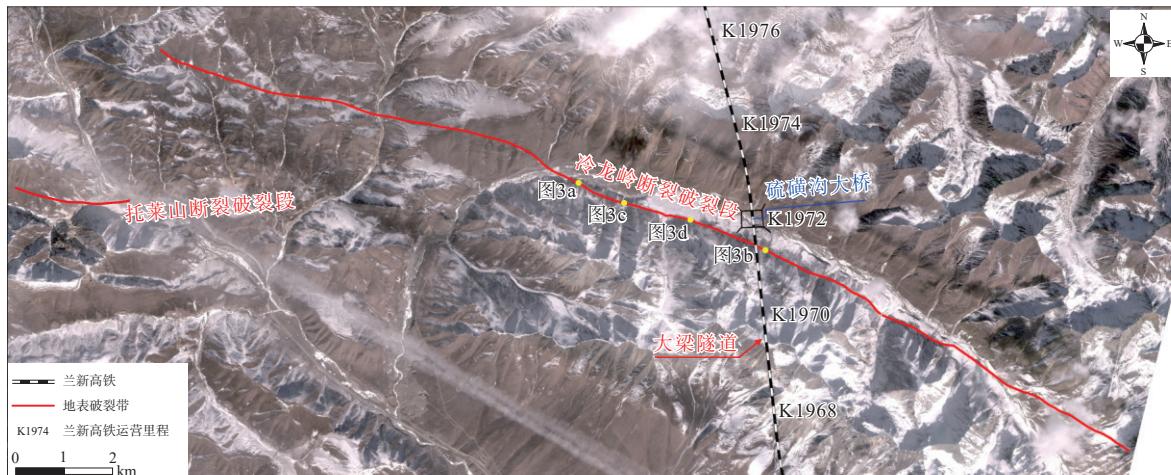
图 2 青海门源 M_s 6.9 地震同震地表破裂带分布图

Fig. 2 Distribution map of the coseismic surface rupture zones for the Menyuan M_s 6.9 Earthquake in Qinghai

门源 M_s 6.9地震最大水平错动位移约为3.1 m, 最大垂直位错约为0.8 m(盖海龙等, 2022)。综合高分辨率卫星影像详细解译和破裂带的野外调查, 在海原断裂带中厘定出两条呈左阶斜列、北西西—南东东走向的地震同震破裂带(图2)。一条发育在托来山断裂的东段, 总长约为3.8 km, 以左旋走滑变形为主, 局部兼向南逆冲性质, 最大走滑位移约为0.5 m。另一条发育在冷龙岭断裂的中—西段, 为此次地震的主破裂带, 呈北东向微凸的弧形展布, 全长约为21.5 km, 整体以左旋走滑变形为主兼向北逆冲性质, 最大走滑位移约为3.1 m, 与已有实测数据(盖

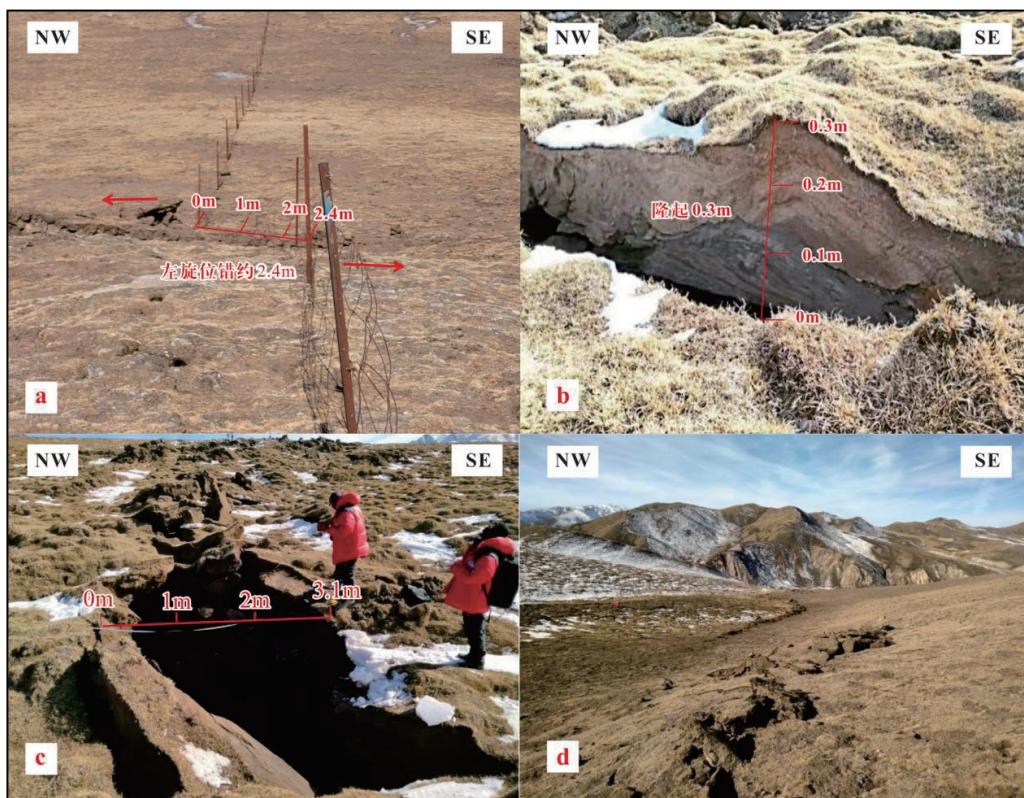
a—铁丝网围栏左旋错位; b—地表破裂形成的地震陡坎; c—张裂缝; d—左阶雁行状挤压鼓包

图 3 海原断裂带冷龙岭—托莱山断裂段同震地表破裂 (具体位置见图 2)

Fig. 3 Coseismic surface ruptures of the Lenglongling–Tuolaishan fault in the Haiyuan fault zone (The location is shown in Fig. 2)

(a) Left-lateral displacement of wire mesh fence; (b) Seismic scarp formed by surface rupture; (c) Tensile crack; (d) left echelon compressional bulge

海龙等, 2022)一致。地表破裂表现最明显区段与兰新铁路大梁隧道呈大角度相交并穿过隧道(韩帅等, 2022; 潘家伟等, 2022), 导致其 K1971+341—K1971+691 里程段的结构破损严重。地表破裂变形主要表现为剪切裂缝、雁列状挤压脊、拉张裂隙和断坎等多种类型(图 3)。铁轨、洞壁及路基等发生强烈的缩短隆起和走滑位错等变形; 同时, 隧道北侧的硫磺沟大桥与桥墩也发生了不同程度的变形和倾斜变位。

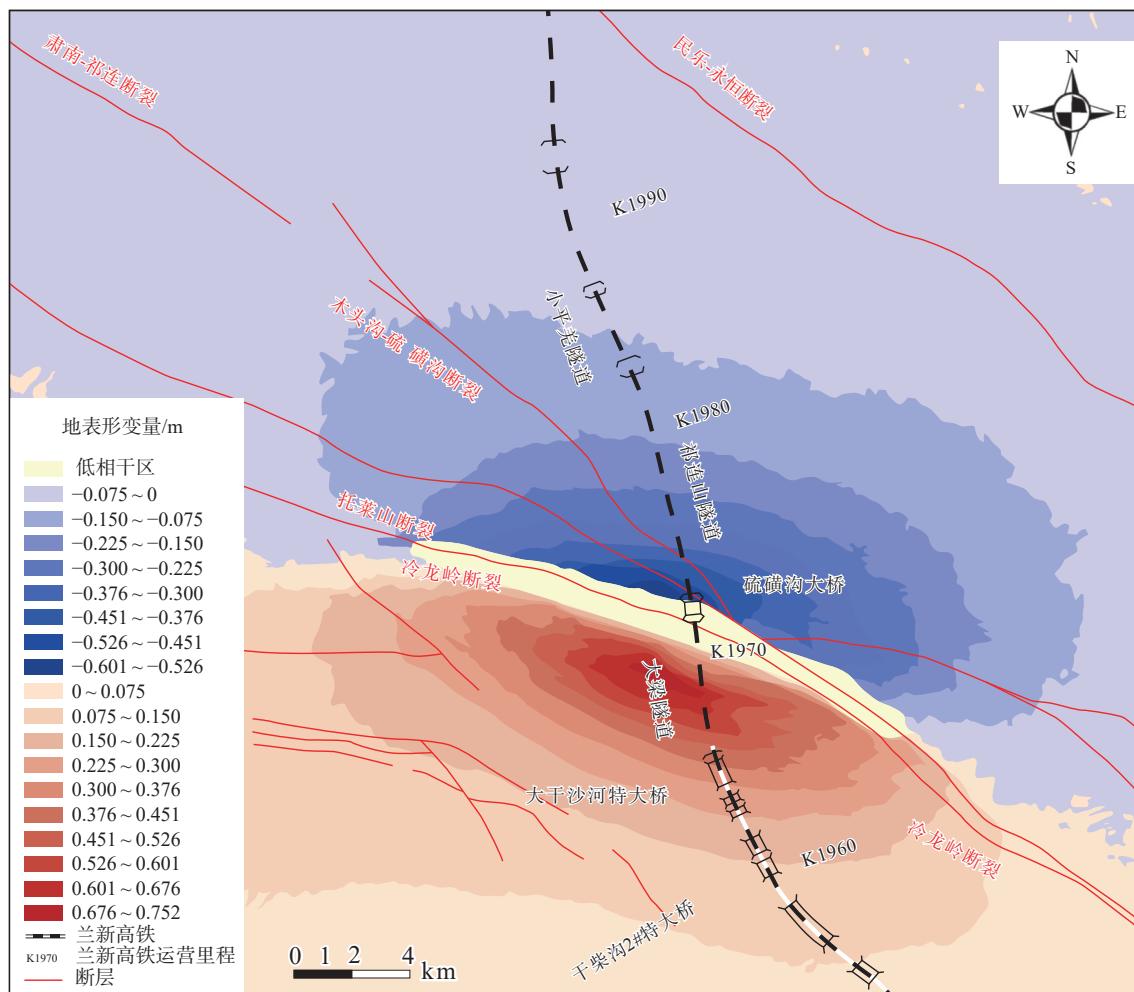
破裂带附近地表破裂或相对滑动剧烈,形成一定宽度的低相干区域,做掩膜处理

图 4 门源地震 D-InSAR 地表形变特征

Fig. 4 D-InSAR surface deformation map of the Menyuan earthquake

The surface rupture or relative slide near the fracture zone is severe, forming a low coherence area of a certain width, and masking is performed.

文章获取了震前 2021 年 12 月 29 日和震后 2022 年 1 月 10 日覆盖整个破裂区的分辨率为 20 m 的 Sentinel-1 雷达卫星数据。采用差分干涉测量(D-InSAR)技术对破裂区的地表形变状况进行计算, 得到破裂区的同震形变图(图 4)。结果显示, 此次地震的形变范围达到 30 km×30 km 以上, 发震断裂为

海原断裂带冷龙岭—托莱山断裂段，并显示断裂北盘沉降、南盘抬升的形变特征。降轨影像卫星视线方向 (LOS) 南盘和北盘最大形变量约为 75 cm、-55 cm，升轨影像 LOS 方向南盘和北盘最大形变量分别约为 45 cm、-60 cm，升、降轨影像最大 LOS 方向形变量指示跨发震断裂的垂直变形幅度最大可达 135 cm。同震形变带主体沿北西西—南东东向的海原断裂带冷龙岭—托莱山断裂段展布，长度超过 20 km。

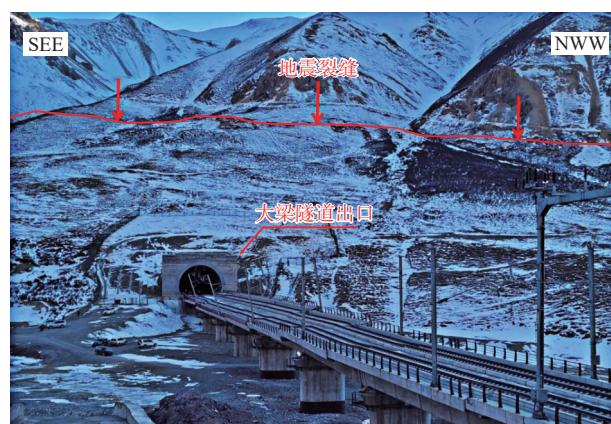
图 5 发震断裂大角度切穿大梁隧道

Fig. 5 The seismogenic fault cutting through the Daliang tunnel at a large angle

由于发震断裂大角度切穿大梁隧道(图 5)，地表破裂和形变显著。大梁隧道 K1971+341—K1971+691 里程段震害表现最为严重，其次为 K1971+691—K1972+088(隧道出口)里程段，其余区间的震害相对轻微。

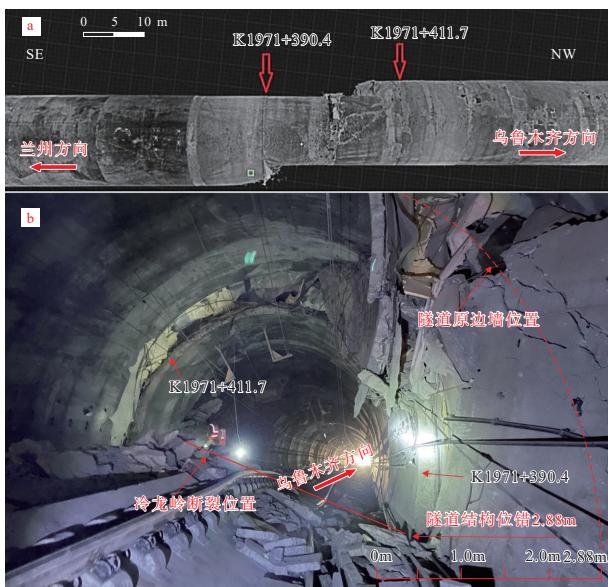
仰拱隆起、钢轨扭曲、边墙走滑位错及一些伴生破坏。其中仰拱沿隧道中线隆起高为 0.3~0.5 m，左、右线轨道板分别向两侧倾斜，倾角约为 40°，钢轨扭曲变形严重，两侧排水沟堵塞、盖板挤压隆起，水沟侧壁倾斜、局部破坏，电缆槽盖板挤压隆起、凹凸不平，衬砌环向挤压破坏，隔水层外露，隧道拱部大面积脱落，大量钢筋变形断裂外漏。在 K1971+400 里程前后各 60 m 范围内，隧道在横向和垂向上均发生了断错，其中隧道边墙错断出现在 K1971+390.4—K1971+411.7 里程段附近，最大错位处为里程 K1971+400，该处沿隧道横向(即垂直隧道轴向方向)发生左旋错动约为 2.88 m，沿隧道纵向(即平行隧道轴向方向)错动 0.2~0.7 m，同时可见 0.3~0.8 m 宽度不等的地裂缝发育(图 6)。

a—隧道断裂处云俯视图; b—隧道被断裂左旋错动实景(镜向北)

图 6 切穿大梁隧道的同震断裂及其破坏效应
Fig. 6 Coseismic fault cutting through the Daliang tunnel and its failure effect

(a) Top view of the tunnel rupture zone; (b) Actual scene of the tunnel subjected to left-lateral offset from the rupture (view facing north)

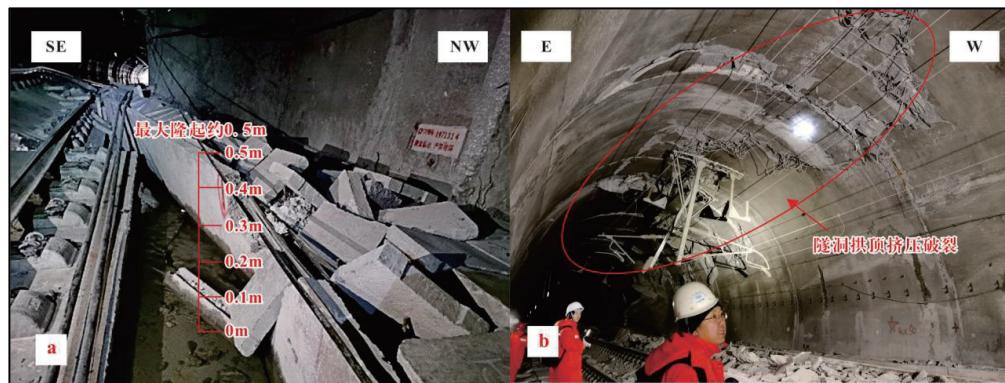
该段震害主要表现为拱顶挤压破裂、道床隆起、衬砌与仰拱拉张破裂等(图 7)。其中，中间底

板的隆起变形幅度最大约为 0.5 m, 道床中心的仰拱填充面左旋错动为 7~8 cm, 并出现轨道板隆起和钢轨凸起变形。同时, 可见隧道底板两侧的盖板隆起、水沟侧壁破坏和拱部剥落掉块等现象, 最大剥落面积达 0.6 m², 局部出现渗漏水。

a—道床板隆起变形; b—隧道拱顶挤压破裂

图 7 K1971+691—K1972+088 (隧道出口) 里程段的同震破坏效应

Fig. 7 Coseismic failure effect of the section from K1971+691 to K1972+088 (tunnel exit)

(a) Deformation with uplift of the bed plate; (b) Compression rupture on the tunnel arch

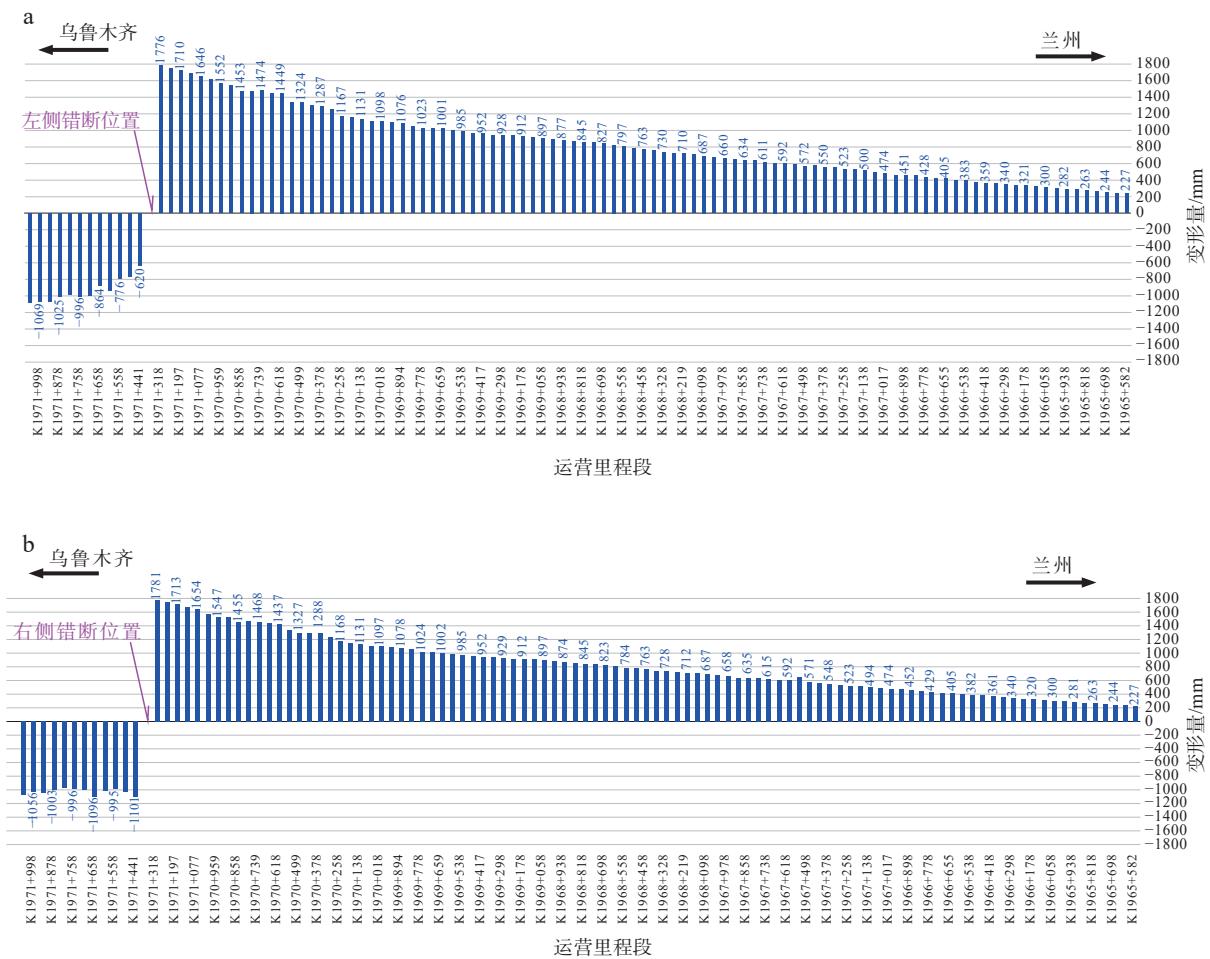
“+”为向隧道右侧(即北东东方向)位移;“-”为向隧道左侧(南西西方向)位移

a—线路左侧(即隧道轴线西侧壁)CPⅢ平面变形量分布规律图;b—线路右侧(即隧道轴线东侧壁)CPⅢ平面变形量分布规律图

图 8 大梁隧道线路 CPⅢ 平面变形量分布规律图

Fig. 8 Distribution of CPⅢ plane deformation of the Daliang tunnel line

(a) Distribution of CPⅢ plane deformation on the left side of the line (the west side wall of the tunnel axis); (b) Distribution of CPⅢ plane deformation on the right side of the line (the eastern side wall of the tunnel axis)

“+” indicates displacement towards the right side of the tunnel (north-east direction), and “-” indicates displacement towards the left side of the tunnel (south-west direction).

过大梁隧道, 断裂与大梁隧道相交于 K1971+400 里程处, 两者夹角约为 70° 。此次主要采用大梁隧道震前 2020 年 12 月的 CP III 观测数据和震后 CP III 复测结果, 将跨过大梁隧道 CP III 观测点北向、东向坐标变化值转换成沿铁路横向、垂向变化值后, 可获得沿大梁隧道线路震后的 CP III 平面变形量分布规律图(图 8); 并据此得到震后大梁隧道线路震后的 CP III 高程变形量分布规律图(图 9)。

结果显示, 同震破裂导致大梁隧道发生显著的左旋位错。在主破裂带南侧, 从大梁隧道进口到 K1971+400 里程处, CP III 点位表现为向隧道右侧(即北东东方向)位移, 并且横向位移存在由小到大的变化, 位移量从 0.22 m 增大到 1.78 m; 在主破裂带北侧, 从 K1971+400 里程处到大梁隧道出口, CP III 点位表现为向隧道左侧(即南西西方向)位移, 横向位移量为 0.62~1.10 m。根据 CP III 观测结果, 大梁隧道最大左旋位错出现在 K1971+400 里程处, 最大位错量为主破裂带南、北两侧最大横向(即垂直隧道轴向方向)位移之和, 约为 2.88 m。

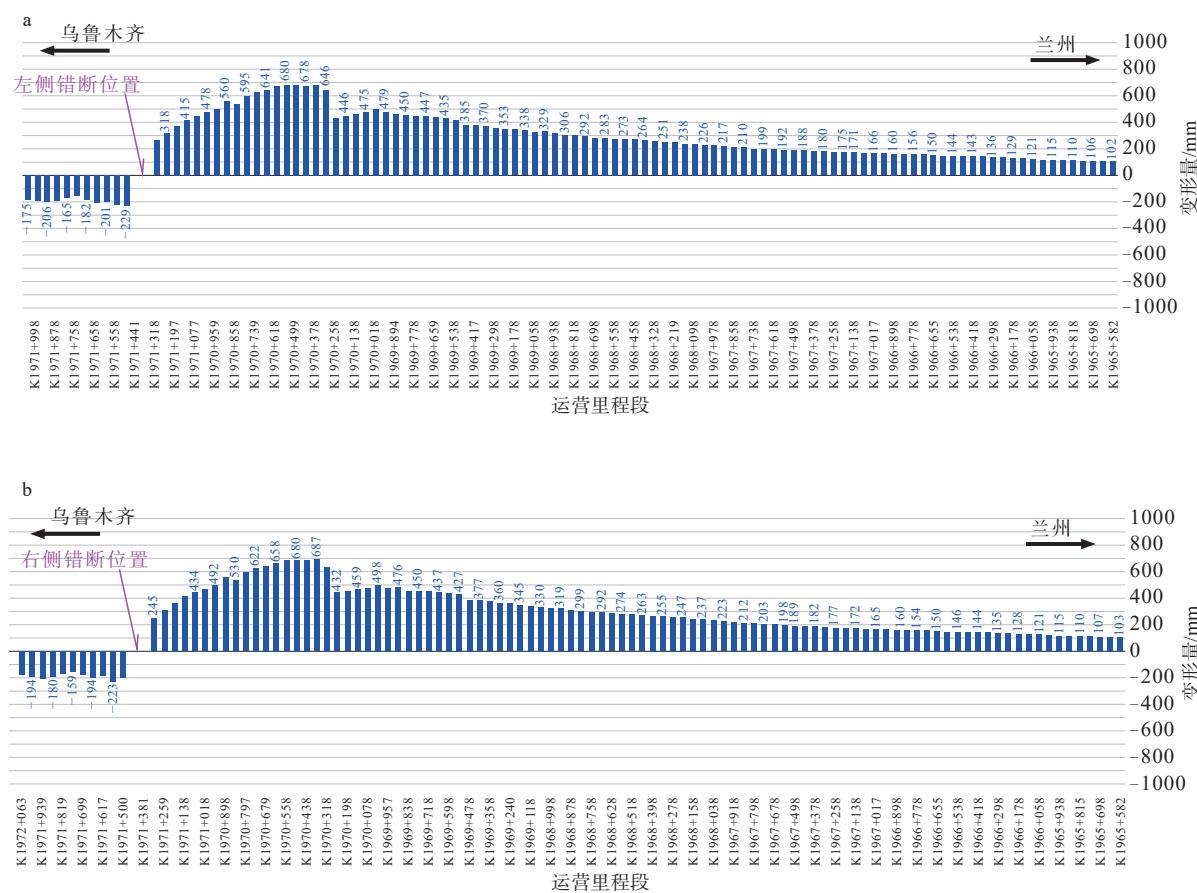
“+”表示抬升量；“-”表示沉降量

a—线路左侧(即隧道轴线西侧壁)CP III 高程变形量分布规律图; b—线路右侧(即隧道轴线东侧壁)CP III 高程变形量分布规律图

图 9 大梁隧道线路 CP III 高程变形量分布规律图

Fig. 9 Distribution law of CP III elevation deformation of the Daliang tunnel line

(a) Distribution of CP III elevation deformation on the left side of the line (the west side wall of the tunnel axis); (b) Distribution of CP III elevation deformation on the right side of the line (the eastern side wall of the tunnel axis)

"+" represents uplift, and "-" represents subsidence.

CP III 高程测量结果显示, 从大梁隧道进口到 K1971+400 里程处, 主破裂带南侧 CP III 高程均表现出向上抬升, 最大抬升量出现在 K1970+500 里程处, 达 68.7 cm; 主破裂带北侧 CP III 高程均表现出向下沉降, 最大沉降量出现在 K1971+558 里程处, 达 22.9 cm。主破裂带两侧的最大升、降量相加, 代表了此次同震破裂导致的隧道最大垂直位移量, 约为 91.6 cm。

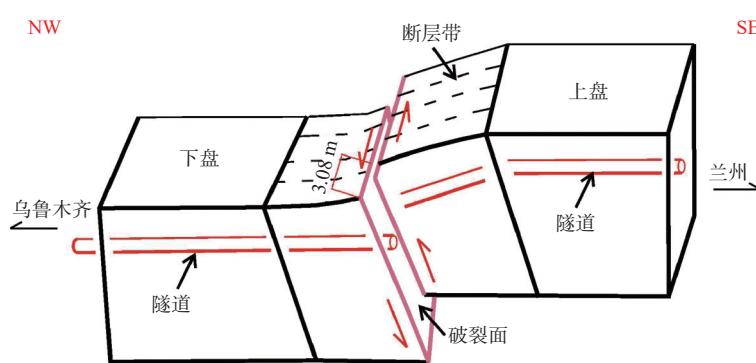
图 10 大梁隧道同震变形机制与破坏效应示意图

Fig. 10 Schematic diagram of coseismic deformation mechanism and failure effect of the Daliang tunnel

综合隧道震害调查和 CP III 观测结果, 同震变形在大梁隧道段主要表现为左旋走滑兼由南向北逆冲, 造成主破裂带北盘沉降南盘抬升。隧道在 K1971+400 里程前后各 60 m 区间内的水平与垂向变形量最为显著, 最大水平错断(断距)出现在 K1971+400 里程处, 达 2.88 m, 考虑到海原断裂带的冷龙岭-托莱山断裂段与大梁隧道夹角约 60° , 断裂位移约等于 $2.9 \text{ m}/\cos 30^\circ$, 换算后对应的断裂最大左

旋位错量约 3.08 m。(图 10)。
