Characteristics of geological hazards and its mitigations of the Ms6.8 earthquake in Luding County, Sichuan Province

铁永波, 张宪政, 卢佳燕, 等. 四川省泸定县 Ms6.8 级地震地质灾害发育规律与减灾对策 [J]. 水文地质工程地质, 2022, 49(6): 1-12.

四川省泸定县 Ms6.8 级地震地质灾害发育规律与减灾对策

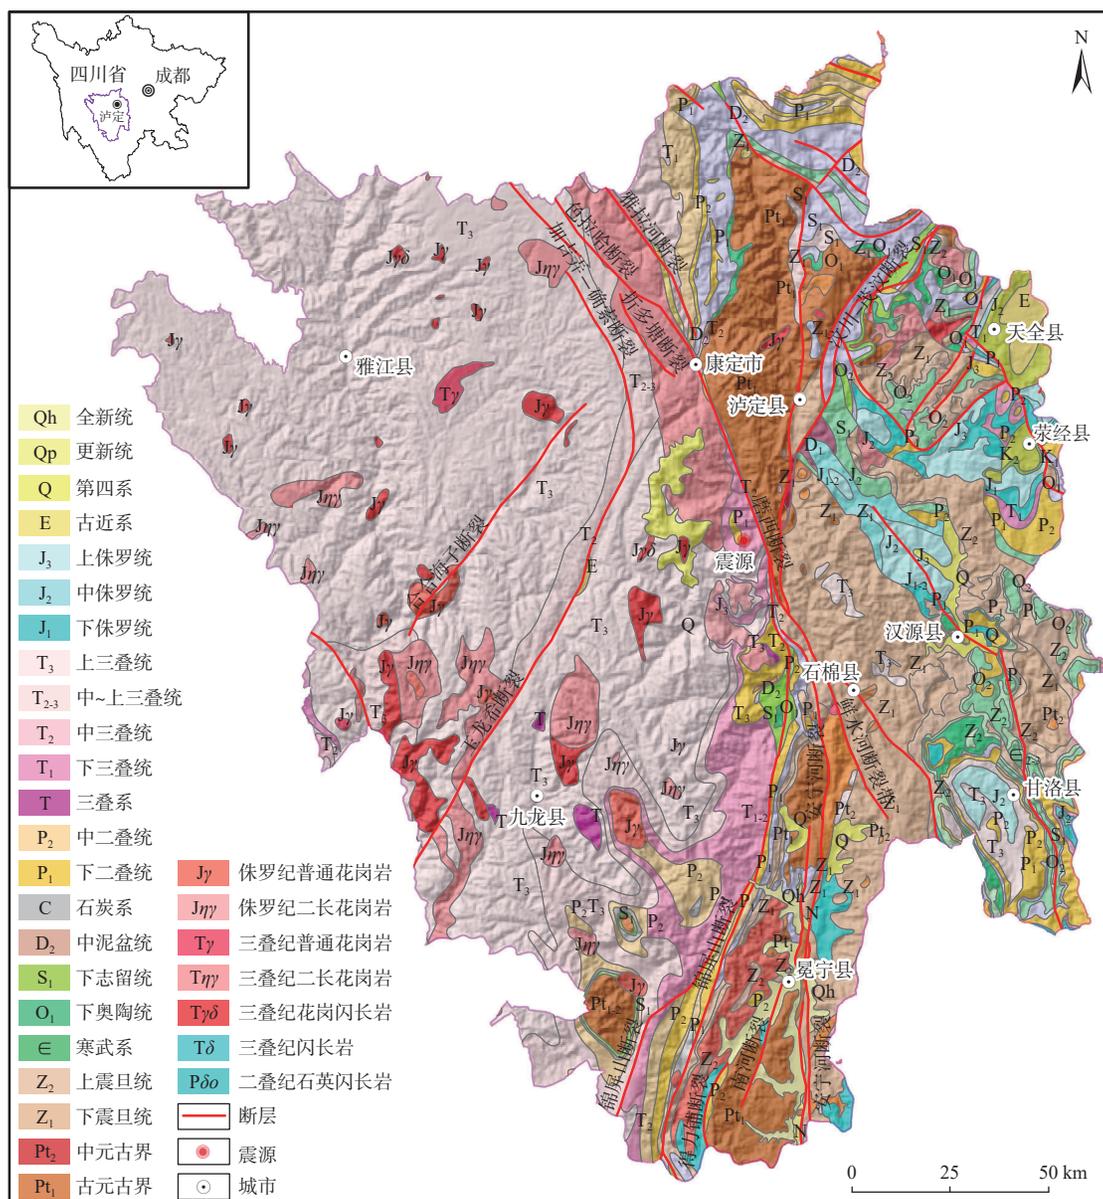
图 1 研究区地质概况图

Fig. 1 Geological overview of the study area

研究区内地层岩性复杂,从区域 1:130 万比例尺地质图(图 1)上可以看出,从第四系至震旦系地层均有分布,广泛出露震旦系(Z)、志留系(S)、泥盆系(D)、石炭系(C)、二叠系(P)、三叠系(T)、古近系(E)和第四系(Q)地层,其中,以中生界、古生界三叠系及元古界变质岩分布最广。研究区西部区域主要出露三叠系的砂岩、板岩和少量石灰岩。研究区东部区域主要出露石英岩、大理岩、白云石、变质砂岩、碳酸盐岩、基性和酸性火山岩。侵入岩体从元古代到新生代均有出露,岩性以花岗岩类、闪长岩类和少量超基性侵入岩为主,属坚硬岩组。花岗岩类主要分布在鲜水河断裂带以西,闪长岩类在研究区北部零星分布。第四系沉积物主要分布在鲜水河及其支流的相邻区域和该区的一些小盆地,包括全新世冲积层、砂、黏土、砾石,更新世冲积层、砾石土、黏土。研究区内多时代、多类型的岩性背景奠定了地质灾害孕灾的复杂性,特别是河谷斜坡上部的破碎岩体在地震下为群发性浅表层崩塌的形成提供了有利条件,而坚硬花岗岩体在高陡临空条件下形成卸荷裂隙,为高位大块体岩质崩塌的形成提供了有利条件。

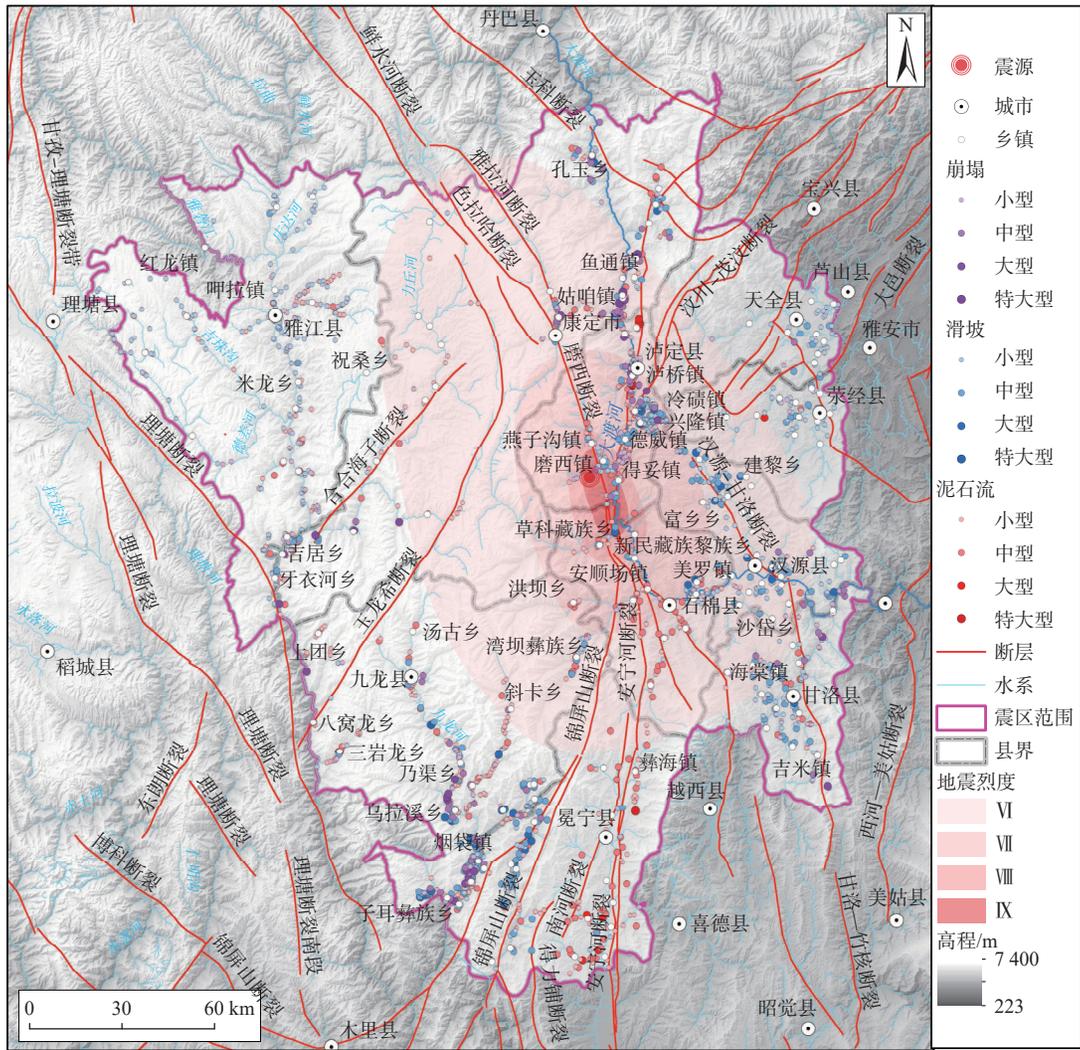
图 2 研究区震前地质灾害分布图

Fig. 2 Distribution of geological disasters before earthquakes in the study area

根据四川省地质灾害隐患点在库统计数据,此次震区 10 县(市)境内有地质灾害隐患点共 1 797 处(截至 2022 年 9 月 4 日),灾害类型主要为滑坡、泥石流和崩塌,其中滑坡 887 处、泥石流 677 处、崩塌 233 处(表 1)。从空间分布特征上看,震前研究区地质灾害主要沿河流呈线状分布。根据应急管理部和中国地震局提供的烈度分布数据,泸定县 Ms6.8 级地震烈度在 VI 度以上影响范围内,已有地质灾害点 722 处,沿大渡河两岸呈线状分布(图 2),主要分布在鱼同镇—泸定县城—得妥镇,安顺场镇—石棉县城—汉源县城。

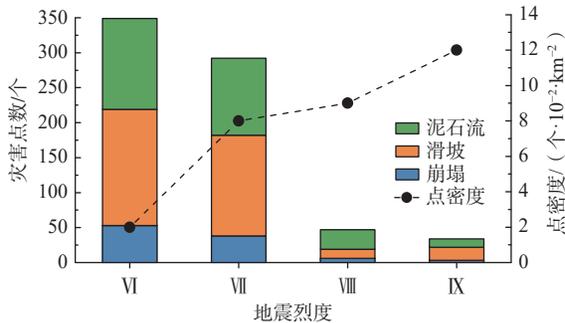
图 3 震区震前地质灾害点与地震烈度统计图

Fig. 3 Geological hazard points and seismic intensity before the earthquake in the study area

泸定县 Ms6.8 级地震影响范围内,震前地质灾害发育,且其分布密度与烈度等级呈正相关(图 3)。烈度在 VIII 度以上影响范围内,已有地质灾害点 81 处,主要分布在燕子沟镇、磨西镇和德妥镇,尤以磨西镇最多,少数分布在草科乡和王岗坪乡。在 VII 度影响范围内,已有地质灾害点 292 处,主要分布在泸定县城—德威镇,少数分布在安顺场镇附近。在 VI 度影响范围内,已有地质灾害点共 349 处,主要分布在泸定县—磨西镇段和石棉县—汉源县段:泸定县—磨西镇段地质灾害点共计 361 处,沿大渡河两岸密集分布;石棉县—汉源县段地质灾害点共计 188 处,沿河流两岸呈散点状分布。

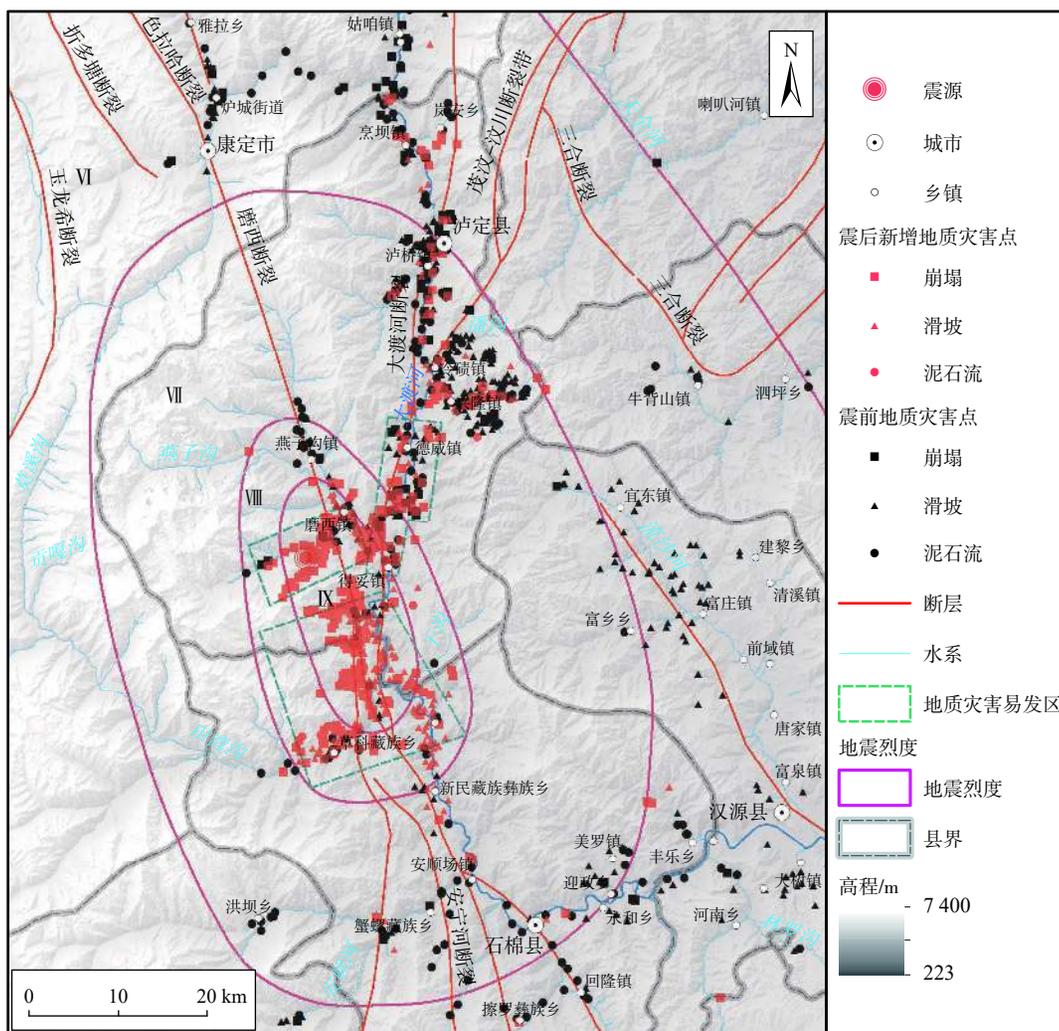
图 4 研究区地震新增地质灾害分布图

研究表明, 此次地震地质灾害类型主要为中、小型规模高位崩塌滑坡, 且集中分布在震中附近地震烈度 IX 度区域, 包括泸定县磨西镇、得妥乡、得妥乡—德威镇段大渡河两岸及石棉县草科乡、王岗坪乡; 地质灾害较为发育的乡镇有泸定县磨西镇、得妥镇和石棉县草科乡、王岗坪乡, 其余地区地震地质灾害发育

程度相对较低(图 4)。磨西镇地震地质灾害主要集中分布在 2 个区域: 一个区域是磨西台地临燕子沟和雅家埂河一侧临空区域, 因磨西台地最大高度可达 110 m, 为冰水堆积和泥石流堆积体, 虽然台地胶结较

Fig. 4 Distribution of new seismic geological disasters in the study area

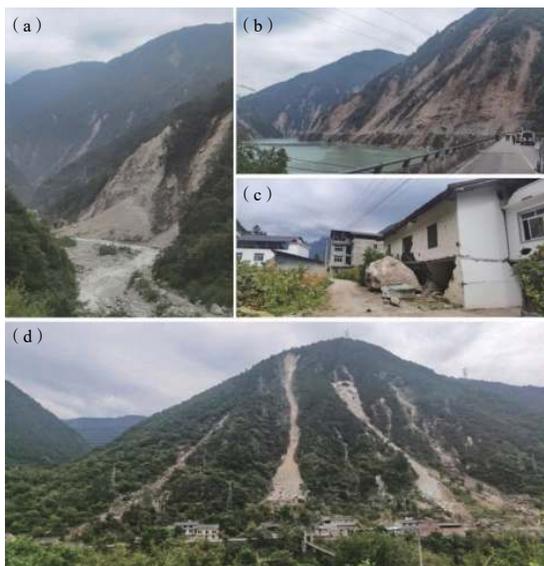
图 5 震区典型地质灾害发育特征

好, 但在强震作用下仍产生大量崩塌, 这些区域的崩塌也是导致磨西镇至得妥乡道路中断的主要原因, 如图 5(a) 所示; 另一个区域是磨西镇两岸高位山体, 主要发育高位崩塌, 多分布在海螺沟两岸、燕子沟磨西段右岸、雅家埂河磨西段左岸坡体中上部, 能划分出单个崩塌的边界, 分布相对较为分散。

泸定县得妥镇和石棉县草科乡、王岗坪乡境内地震烈度 IX 度区域, 地质灾害密集发育在坡体和山脊中上部临空侧, 多为浅表层崩塌滑坡, 且密度极大, 多呈片状分布, 难以划出崩塌之间的边界, 表现为崩塌群形式, 如图 5(b) 所示。

得妥乡—德威镇段大渡河两岸地质灾害多发育在坡体上部, 崩塌运动表现出 2 种差异显著的模式: 相对较为坚硬的块石多以落石方式崩落, 且运动距离较远, 部分直接进入大渡河, 多数停留在坡脚下公路、

Fig. 5 Characteristics of typical geological hazards in seismic area

民房处及低洼地带并成灾,这也是导致得妥镇至德威镇段道路遭受影响的主要原因,如图 5(c)所示;相对碎裂的岩体崩落后,在运动过程中解体,以碎块石的方式堆积在斜坡中下部地形低缓处,其运动距离相对较短,造成直接破坏的范围有限,如图 5(d)所示。

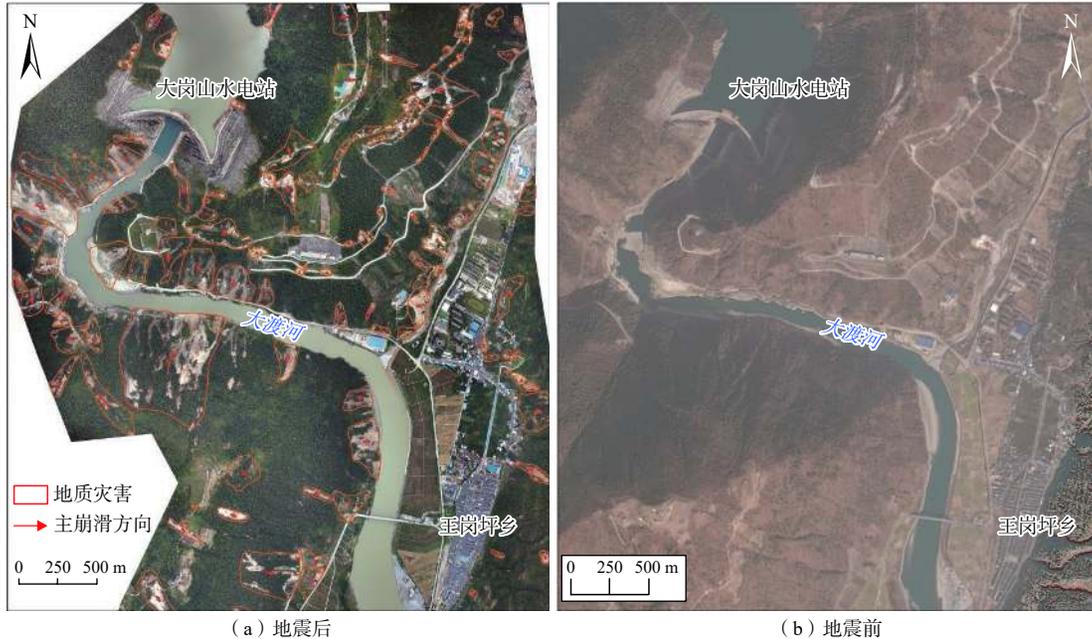
图 6 大岗山水电站至王岗坪乡地震前后地质灾害发育情况对比图

长约 3.2 km, 宽约 2.8 km, 面积约 9 km², 基于如图 6(a) 所示的 9 月 9 日震后航空影像解译可知, 该区域共发育地质灾害点 119 处, 其中滑坡 91 处, 崩塌 28 处, 平均发育密度为 13.2 处/km²。根据灾害规模统计结果可知, 大型规模地质灾害发育 2 处, 中型发育 36 处, 小型

发育 81 处, 灾害规模以中小型为主。由图 6(b) 所示的该地区震前光学影像可知, 未见明显地质灾害发育, 说明该区域地震前后灾害发育密度和数量发生明显变化。

Fig. 6 Comparison of the distributions of geological hazards in the area from Dagangshan hydropower station to Wanggangping Town before and after the earthquake

注: (a) 地质灾害解译分布图来源于四川省地质调查院, 数据由四川测绘地理信息局提供, 分辨率 0.2 m, 航摄时间 2022 年 9 月 9 日; (b) 影像数据为资源三号卫星影像, 分辨率 2 m, 拍摄时间 2021 年 2 月 10 日。

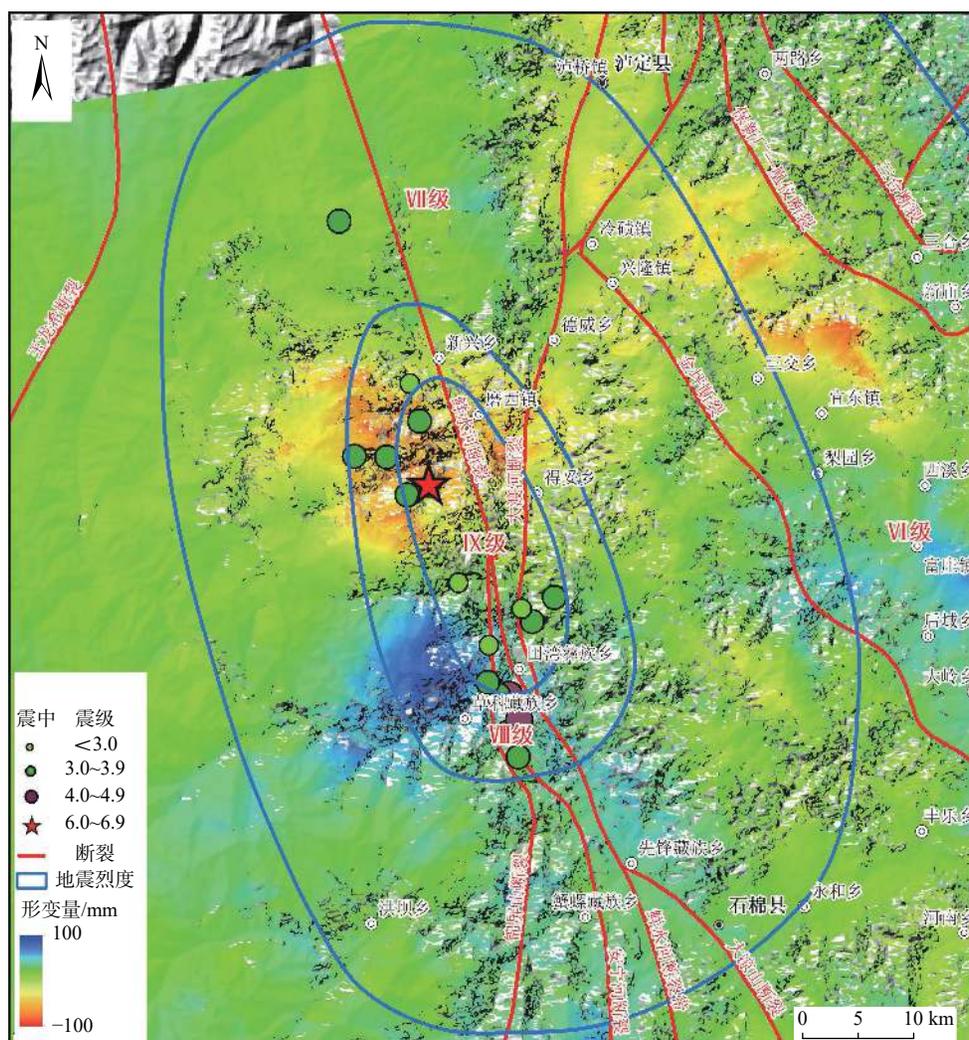
图 7 研究区地震 InSAR 形变场 (四川省地质调查院提供)

地震烈度是对地表变形影响最为显著的影响因素。本文基于 2022 年 8 月 14 日与 2022 年 9 月 7 日获取的 2 期 Sentinel-1 升轨数据, 使用 DInSAR 技术获得了泸定地震同震 InSAR 形变场(图 7)。其中红色(负值)表示该区域下沉变形, 蓝色(正值)表示抬升变形。通过将 InSAR 结果和地震烈度叠加分析可知, 磨西镇和草科乡是研究区内地表形变最强烈的区域, 这与地震烈度的分布是相吻合的。因此这 2 个区域内的地震灾害发育概率相对较大。

Fig. 7 Seismic InSAR deformation field in the study area (provided by Sichuan Geological Survey)
