## 西昌—香格里拉拟建高速公路廊道 不良地质体遥感识别

**摘要:**随着我国高速公路建设不断向西部山区发展,面临的崩塌、滑坡、泥石流等不良地质问题日益突出,迫切需要在选线阶段利用新的技术手段对拟建高速公路沿线不良地质体进行早期识别。以西昌—香格里拉拟建高速公路廊道为研究区,利用“天-空-地”一体化综合遥感手段,识别出不良地质体 174 处,其中滑坡 74 处、崩塌 40 处、泥石流 16 处、堆积体 44 处,利用小基线集合成孔径雷达干涉测量技术探测到 26 处不良地质体具有形变信号。针对磨盘山隧道—雅砻江桥段、牦牛山隧道出口段和下麦地隧道出口段不良地质体发育密集、规模大、稳定性差、对拟建线路威胁极大的区段,项目组开展了详细调查和分析评价。研究结果为西昌高速线路比选和后期详细勘查提供了支撑,也为线路工程不良地质体调查评价提供参考。

## Remote sensing detection of adverse geological bodies along Xichang-Shangri-La expressway

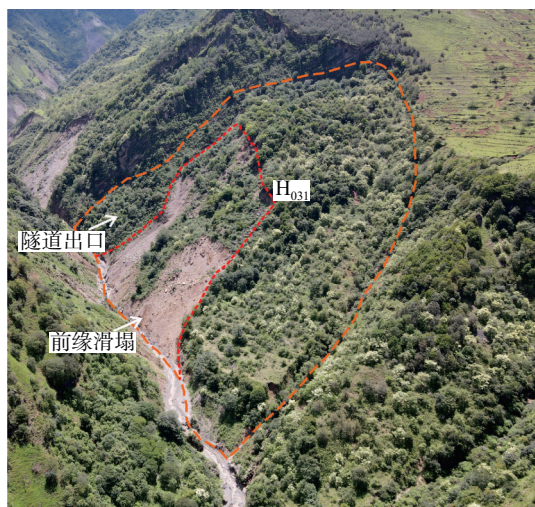
图 11 滑坡 H<sub>031</sub> 无人机影像Fig. 11 UAV image of loose landslide H<sub>031</sub>

断层构造活动造成该区段岩体破碎, 堆积层厚度较大, 坡脚受沟道流水强烈掏蚀, 形成密集滑塌。H<sub>031</sub> 为沟道左岸一处小型滑坡, 前缘已发生多次滑塌, 中部拉裂台坎明显, 两侧发育冲沟, 降雨和流水持续作用将导致滑坡变形加剧。工可推荐线牦牛山隧道出口位于 H<sub>031</sub> 滑坡下部, 紧邻滑塌区, 建议对线路进行局部优化, 比选线路 2-2 和 2-4 在该区段均以隧道方式通过, 不受不良地质体影响(图 11)。

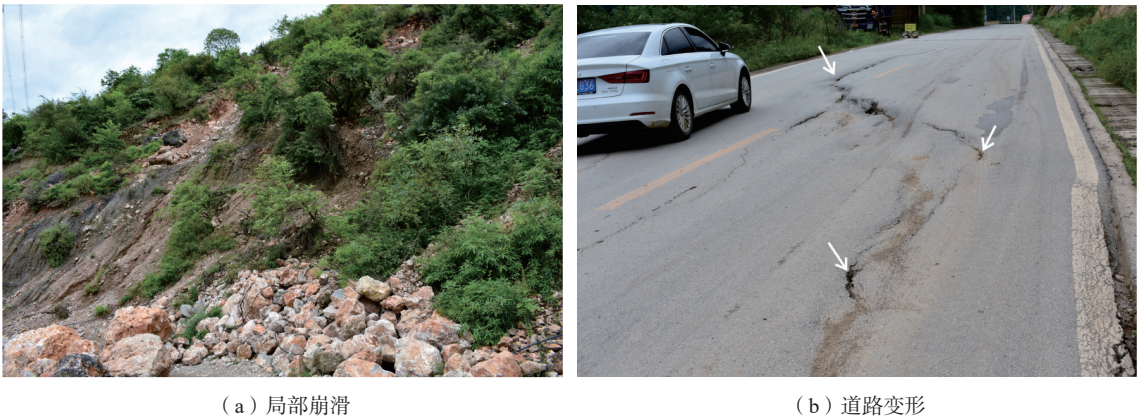
图 13 下麦地隧道出口段不良地质体现场照片  
Fig. 13 Scene photograph of the exit section of Xiamaidi tunnel

通过实地调查发现, 堆积体 D<sub>029</sub>、D<sub>030</sub> 下伏基岩为中厚层砂岩夹薄层泥质砂岩, 风化程度高, 倾向与坡向基本一致, 稳定性较差。受人类工程活动影响, 坡体多处发生小规模滑塌, 道路变形明显。进一步工程扰动可能加剧堆积体变形。比选线路 2-3 拟以桥梁、路基方式通过堆积体 D<sub>030</sub>, 受影响较大, 建议线路采取“绕避”措施(图 13)。
