## 雅砻江中游楞古水电站夏日滑坡发育特征及稳定性分析

裴小龙, 杨瀚文, 宋东阳, 杨斌, 田野

Characteristics and stability analysis of Xiari landslide at Lenggu hydropower station in the middle reach of the Yalong river

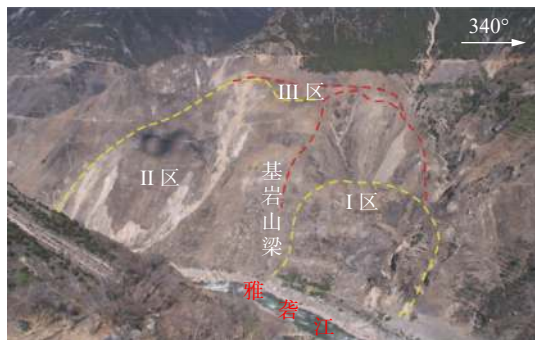
图3 夏日滑坡分区特征

Fig. 3 Xiari landslide zoning characteristics

夏日滑坡在地形地貌、边坡结构以及变形破坏现状等方面有很大差别,文章根据坡体的地貌形态、物质组成、边坡岩体结构特征以及变形破坏现状,将夏日坡体划分为三个区(图 3),并对各区的稳定性做出定性的

I区: 为夏日边坡老滑坡区,位于夏日村坡下临江一侧<sup>[8]</sup>。老滑坡体后缘较为宽大,前缘缩口。主断壁高220 m,滑坡残体后缘高程2560 m左右,前缘河床部位高程约2350 m,横向宽350 m,厚度20~50 m,前缘剪出口位于2360~2380 m高程,高出河水面约5~30 m,沿线可见泉水呈带状渗出。I区上下游边界清晰,两侧均为基岩陡壁。上游侧基岩因卸荷风化强烈,岩体较为破碎,在坡脚附近,可见完整的变质砂岩出露。下游侧岩体被花岗岩脉穿插,可见清晰的结构特征。

II区: 位于I区下游侧的基岩山梁为界的下游部位,为夏日滑坡现状崩滑区,被上下游基岩山梁所围限。滑坡体物质组成为:上部为斜坡崩塌物以及基岩风

III区: 为夏日滑坡后缘区,表层主要为青灰色砂岩与灰黄色花岗岩块石,地形坡度与夏日滑坡原始地表坡度相近,表现为前缘较为宽缓,后缘较陡。相对而言此区属于稳定区,故不作为重点调查区进行研究。

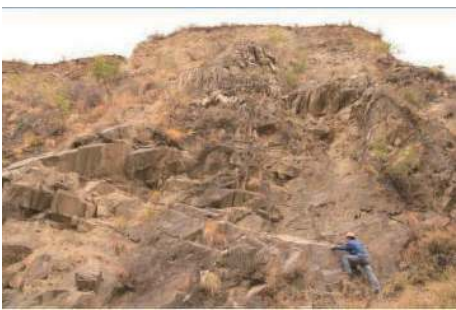
图 7 II 区岩体结构特征  
Fig. 7 The rock mass structure characteristics of zone II

征,岩体被切割为块状结构,较为破碎,并可见错动擦痕,主要结构面产状为:110°∠25°、240°~267°∠53°~60°和35°∠20°,岩体被切割为块状结构(图7),结构面赤投影见图8(面⑤为坡面产状),其前缘稳定性储备不高。
