## 黄河上游曲哇加萨滑坡“9·20”动力学过程模拟与分析

周 保<sup>1</sup>, 马 涛<sup>1</sup>, 魏正发<sup>1</sup>, 王文沛<sup>2</sup>

## Dynamic simulation and analysis of “9·20” sliding process of Quwajiasa landslide in the upper reaches of Yellow River

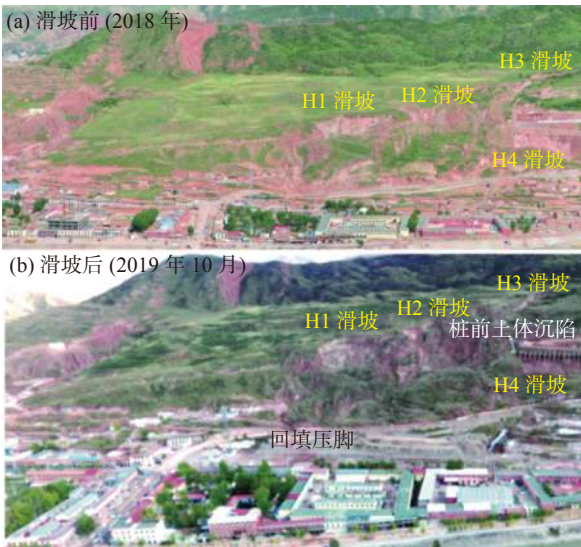
图 3 曲哇加萨滑坡发生前后对比

2019 年 9 月 20 日,曲哇加萨老滑坡东北段中前缘 H1、H2、H4 滑坡发生滑动,造成路面隆起、损毁公路 400 m,18 户居民受灾,51 间房屋倒塌。H4 滑坡滑动后造成原来公路的 20 根抗滑桩裸露,悬臂 5~10 m,出现桩间土坍塌变形,桩后 H3 滑坡内也形成多条纵向裂缝。灾害发生后,采取了拆除房屋和回填压脚措施<sup>[2]</sup>(图 3—6)。

Fig. 3 Comparison before and after the occurrence of Quwajiasa landslide

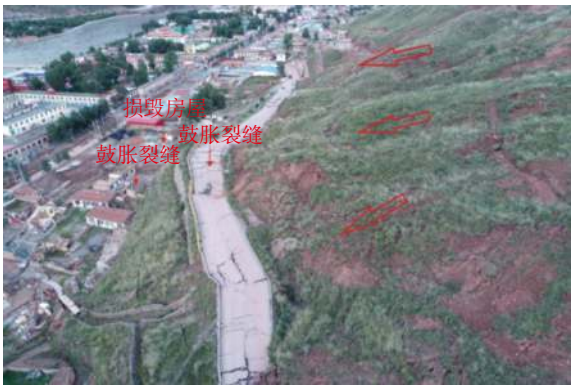
图 4 曲哇加萨“9·20”滑坡前缘

Fig. 4 Frontal edge of “9·20”landslide in Quwajiasa

由图 4—5 可以看出,临近公路位置 H1、H2 滑坡前缘发育多处土体解体,并挤压公路产生多处放射状鼓胀张拉裂缝,裂缝宽度 30~60 cm,深度 2 m,裂缝走向与滑坡方向平行或呈小角度相交。公路外侧挡墙产生严重的鼓胀变形,裂缝宽度达 5 cm。公路下方由于滑坡滑动鼓胀导致地表隆起,造成 51 间房屋倒塌。滑坡前缘影响范围至公路挡墙和军功路之间。

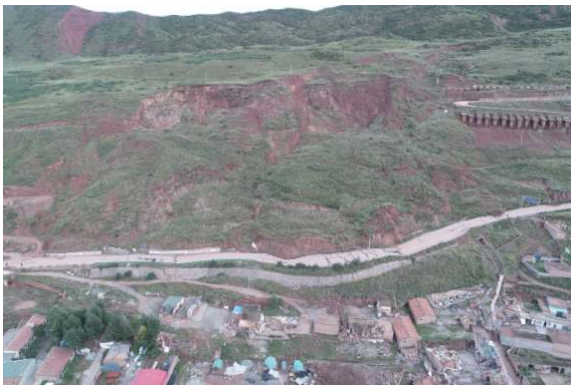
图 5 前缘鼓胀引起房屋倒塌

Fig. 5 The swelling of the front edge caused the houses to collapse

为避免滑坡进一步变形致灾, 灾害发生后, 采取了拆除房屋、回填压脚及截排水措施, 9 天后, 该滑坡逐渐趋于稳定状态。

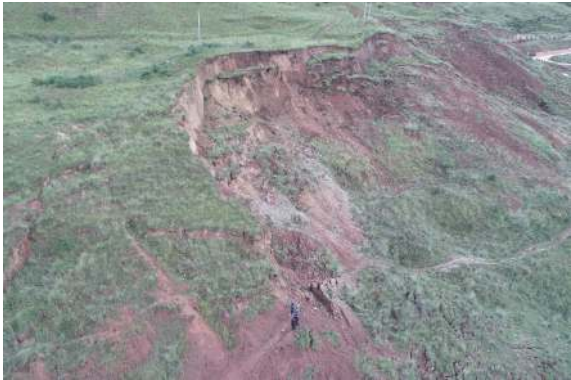
图 6 曲哇加萨“9·20”H1 滑坡后缘

Fig. 6 Back edge of “9·20”H1 landslide in Quwajiasa

由图 6 可以看出,H1 滑坡后缘陡坡下错约 2.0 m,

侧界清晰, 滑坡呈现蠕滑特征, 表面裂缝遍布。现场后缘可见水体入渗迹象, 土体含水量较高。
