## 甘肃舟曲江顶崖滑坡堆积层剪切特性与强度参数分析

**摘要:** 研究古滑坡中堆积层的强度特性是进行滑坡稳定性验算及其防治的重要环节, 为合理确定古滑坡堆积层稳定性分析中的强度参数, 依托甘肃舟曲江顶崖古滑坡治理工程, 以滑体土(碎石土)、滑带土(含砾黏土)为研究对象, 分别取 2 个典型地段采用平推法进行现场大型剪切试验。将试验结果与基于工程类比的力学参数建议值进行了对比分析, 结果发现: (1) 滑带土剪切应变较小时, 剪应力-剪切位移关系曲线有交叉现象, 土样的剪应力随正应力与剪应变的增大呈现递增; (2) 滑体土正应力越大, 应变软化表现得越明显; (3) 滑坡土的残余强度较峰值强度有一定衰减, 但主要表现为黏聚力的减弱, 其内摩擦角几乎没有变化, 是因为在滑体土发生剪切后, 滑带土中的胶结物被破坏, 胶结作用减弱; 泄流坡滑体土的天然残余强度参数内摩擦角在 18.2°到 24.6°之间, 黏聚力在 10.2 kPa 到 12.4 kPa 之间, 滑体土的残余强度参数与工程类比值得到的参数更加接近; (4) 舟曲江顶崖堆积层滑坡滑带土和滑体土的岩体力学参数建议值: 滑带土黏聚力 7.0 ~ 14.8 kPa, 内摩擦角 15.0° ~ 17.5°; 滑体土黏聚力 15.8 ~ 30.9 kPa, 内摩擦角 23.9° ~ 24.4°。

## Analysis of shear characteristics and strength parameters in Jiangdingya landslide, Zhouqu County

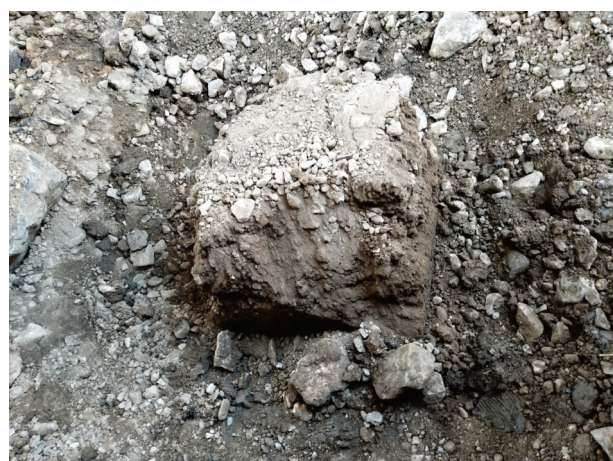
(a) 滑体土

图 2 滑坡滑体土与滑带土

Fig. 2 Site photo of landslide sliding body soil and sliding zone soil<sup>[22]</sup>

复活滑坡的滑体主要由两层土体组成, 上部为碎石土, 主要呈黄褐色或红褐色, 土体组成粒径大小悬殊, 局部含 1~2 m 的大块石, 土体结构松散, 压实度较低, 见图 2(a); 下部以灰黑色炭质板岩碎屑为主, 岩质较软, 极易发生破碎, 遇水易崩解, 原始成因为断层破碎带

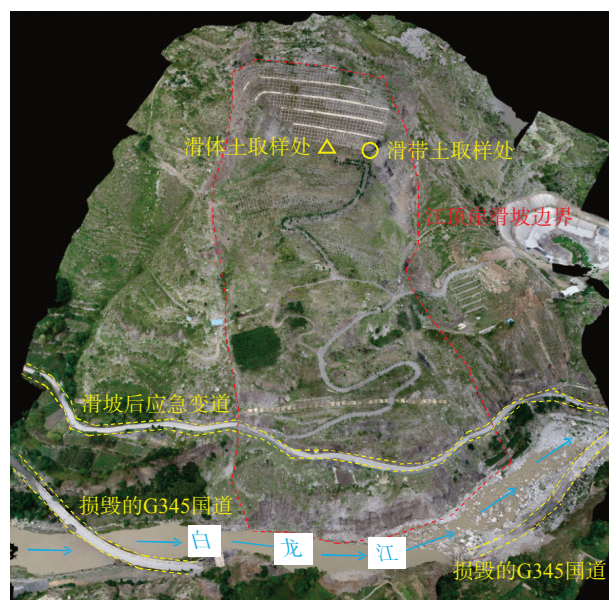
(a) 试验点位置

图 3 直剪试验位置与试验现场

Fig. 3 Direct shear experimental location and test site

滑带土和滑体土试验点位均选在江顶崖堆积层滑坡后缘(图 3)。滑带土和滑体土现场直剪试验各 1 组, 每组试件共 6 块。避免表面扰动岩层影响试验结果, 在试验点处先挖 2.2 m × 12 m × 1.5 m 的试坑, 然后在试坑内凿出尺寸为 0.5 cm × 0.5 cm × 0.35 cm 的 6 块试件, 试件要求新鲜完整, 试件间距不小于试件边长的 1.5 倍(为方便进行多次直剪试验, 预留适宜的空间)。为防止试件在试验过程中发生破坏和便于安装试验仪器设备, 在试
