斜坡降雨侵蚀破坏机理现场试验研究

Analysis of slope erosion and failure mechanism under rainfall conditions based on field experiments: A case study of the residual slope of landslide and debris flow in Hexiluo gully, Ganluo County, Sichuan Province

斜坡降雨侵蚀破坏机理现场试验研究 ——以四川甘洛黑西洛沟滑坡-泥石流残留边坡为例

吕霞, 范刚, 刘大瑞, 林子钰
(四川大学水利水电学院, 四川成都 610065)

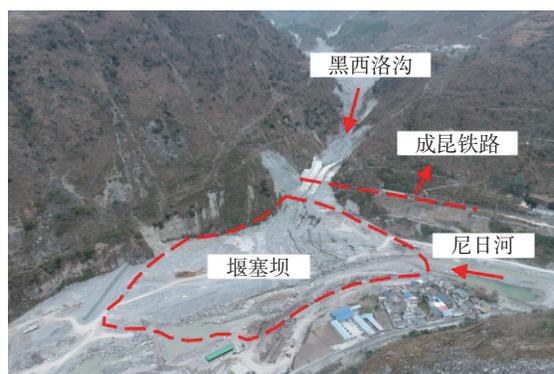
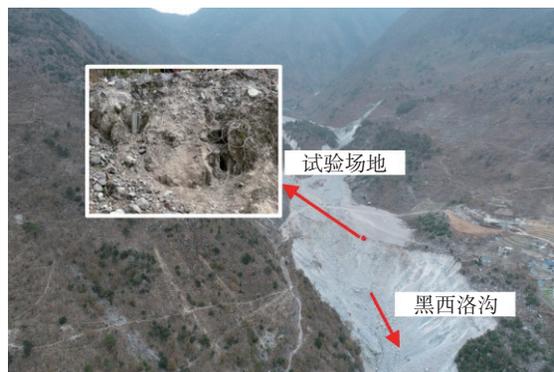
图 1 黑西洛沟堰塞坝全貌和沟内上游影像

黑西洛沟位于四川省凉山州甘洛县,为尼日河右侧的一条小山沟,长度约5 km。经现场调查,沟道两侧松散物源分布广泛,植被不发育。在非汛期,沟内仅有较小溪流流出,在枯水季节沟内偶尔断流。2020年8月31日上午8时,在持续的降雨作用下,黑西洛沟内发生了山洪-滑坡-泥石流-堰塞湖灾害链。灾害发生时,黑西洛沟内原有松散物源被山洪裹挟带走,并在运移过程中不断铲刮沟道底部物源,导致沟边两侧边坡失稳,逐渐演变为滑坡灾害。沟内通道不断下切过程中,两侧岸坡持续垮塌,崩塌体进入沟道后,滑坡规模急速扩大,最终演变为泥石流灾害。大量泥石流物源几乎呈垂直状态冲入尼日河,形成堰塞坝,堵塞尼日河,如图1(a)所示。经现场测量,形成的堰塞坝沿河道纵向方向长度约200 m,顺河向长度约为400 m,高度约30 m,堰塞坝体积约 $100 \times 10^4 \text{ m}^3$ 。堰塞坝自然溃决后冲毁下游场镇、村庄、学校和道路,造成阿兹觉乡一千余名群众受灾,3人失踪,黑西洛沟口的成昆铁路桥梁被冲毁,成昆铁路断道数月,堰塞坝下游的国道G245约1.2 km道路和多处桥梁被掩埋、冲毁,多栋房屋损毁,经济损失严重。堰塞坝材料在下游1 km范围内淤积,导致下游阿兹觉村挖哈组、乃牛组两个组被完全掩埋。

(a) 处置后的堰塞坝全貌

(b) 黑西洛沟上游影像

余边坡上进行, 试验边坡高度约为 2.2 m, 宽约 2.0 m, 坡长约 3.0 m, 天然坡度约为 49°, 如图 1(b) 所示。降雨试验前对坡面进行简单平整, 清除坡面杂草、大块石等影响坡面径流和入渗的障碍物。现场筛分试验测得黑西洛沟内松散堆积体的颗粒级配曲线如图 2 所示^[18]。

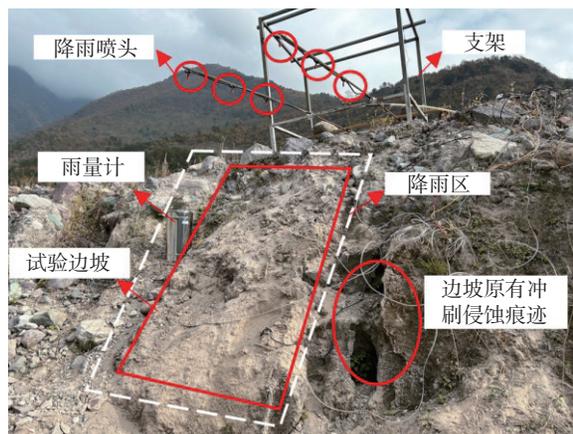
图 3 现场降雨试验装置

降雨装置主要包括支架、雨水输送管道、喷头和雨

量计。喷头设置在边坡顶部并延伸至坡面, 喷头顶面可通过调节流量的方式模拟不同的雨强。

试验中设计了两排喷头, 试验中经过多次调试, 最终确定喷头间距约为 0.7 m, 每排喷头间距约为 0.5 m, 经现场观察, 这一间距能够确保坡面降雨的均匀性。雨量计放置在边坡试验区, 位于试验降雨区内, 以实时测量坡面的降雨量, 测得值能代表试验区的平均雨量, 降雨试验装置如图 3 所示。

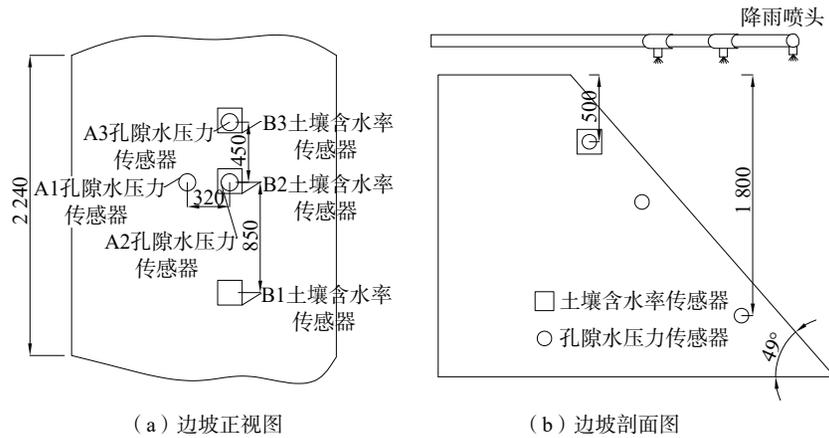
图 4 传感器布置示意图(单位: mm)

试验中数据采集设备包括孔隙水压力传感器、土壤含水率传感器、雨量计以及三维激光扫描仪, 其中孔隙水压力传感器 3 个, 土壤含水率传感器 3 个。孔隙水压力传感器量程是 10 kPa, 准确度误差 $\leq 0.5 F \cdot S$, 土壤含水率传感器测量范围 0 ~ 100%。黑西洛沟滑坡灾害的主要原因就是堆积体浅层物源浸水后被冲出, 故为了与灾害实际情况相似, 本次试验所用传感器埋入边坡表层, 深度为 0.3 m。孔隙水压力计和土壤含水率传感器放入预挖的孔洞后, 利用坡体原样土回填后进行人工夯实, 保证夯实后孔内的土体与天然状态一致。边坡尺寸和传感器埋设的位置如图 4 所示。三维激光扫描仪立于边坡的正面, 通过不同阶段的扫描, 以获取降雨过程中边坡的三维地形点云数据, 由此识别边坡的变形破坏过程。

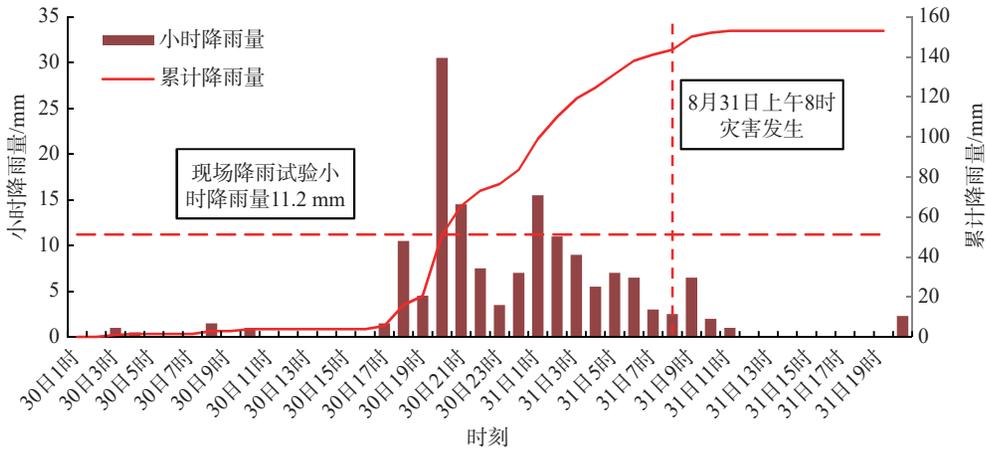
图 5 黑西洛沟临近站点实测降雨量过程

根据甘洛县水利局的实测数据, 本次灾害发生前后黑西洛沟临近监测站点的降雨数据如图 5 所示。临近监测站点位于苏雄镇, 距离灾害点约 500 m, 本站点降雨数据可以代表真实的降雨量。灾害发生时当地已连续降雨约 15 h, 持续降雨导致沟内的松散物源浸水饱和, 并最终被沟内山洪裹挟冲出, 诱发链生的滑坡、泥

石流和堰塞湖灾害, 降雨是此次灾害链发生的主要诱因。为了更好地分析灾害链发生机理, 试验降雨量尽量保证与灾害实际情况相符。受现场试验条件限制, 经雨

量计实测, 此次现场试验共计降雨量为 28 mm, 降雨历时 150 min, 小时降雨量为 11.2mm, 试验小时降雨量与灾害发生时的降雨量接近, 如图 5 所示。

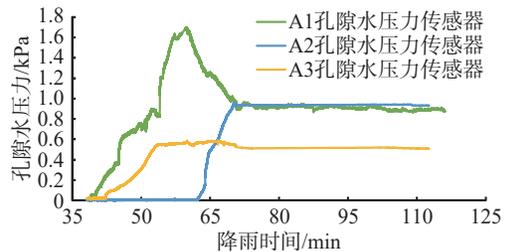
图 6 孔隙水压力随降雨历时的变化规律

根据现场监测结果, 得出降雨过程中边坡内孔隙水压力随降雨历时的变化规律, 如图 6 所示。

由图 6 可知, 边坡体内孔隙水压力的变化过程大致可分为三个阶段: 加速上升、下降和趋于稳定。降雨初期, 雨水未入渗至坡体内部, 孔隙水压力传感器监测数据未发生明显变化。随着降雨的持续进行, 雨水在入渗过程中逐渐汇聚在坡面, 形成坡面径流和坡内渗流, 导

致孔隙水压力开始变化, 其中 A1 和 A3 孔隙水压力传感器在 40 min 至 50 min 陡然增加, 边坡表面出现冲刷痕迹。继续降雨, 边坡表面产生拉裂缝, 雨水通过裂缝不断渗入坡体内部, 孔隙水压力持续上升, 致使边

坡的抗剪强度由于有效应力的减少而降低。降雨后期,边坡表面出现局部塌陷,坡体内部渗透路径发生变化,导致孔隙水压力开始下降。

降雨 35 ~ 50 min 时间段内, A1 和 A3 传感器的孔隙水压力开始增加,坡面有明显的降雨冲蚀痕迹。继续降雨, A1 和 A3 传感器的数据持续上升。降雨 65 min 后, A2 孔隙水压力传感器才开始快速增加,并且此位置的含水率传感器也有明显响应,含水率曲线开始发生变化,土体的含水率开始逐渐上升,含水率和孔隙水压力变化一致。此时坡面的雨水冲蚀痕迹加深,侵蚀破坏范围扩大,土体颗粒被水流带走堆积在坡脚,整个坡面有明显的冲刷破坏。继续进行降雨,边坡土体开裂,雨水沿着拉裂缝进入坡体内部,孔隙水软化了边坡土体,土体有效应力减少,边坡稳定性下降,坡面产生了明显的局部塌陷,内部渗流场发生变化,孔隙水压力开始下降,直至不再改变。

不同位置的孔隙水压力传感器变化有明显差异,原因是, A3 传感器位于坡顶, A1 传感器位于边坡中部,降雨过程中, A1 传感器由于受到降雨入渗和上部土体水分沿拉裂缝入渗的补给,上升速度更快,孔隙水压力相较更大。A2 孔隙水压力传感器数据明显滞后,因为该传感器周围有无法清理的大块石,降雨过程中,雨水流经坡面,块石改变了雨水的渗流路径,导致其渗透速度变慢。

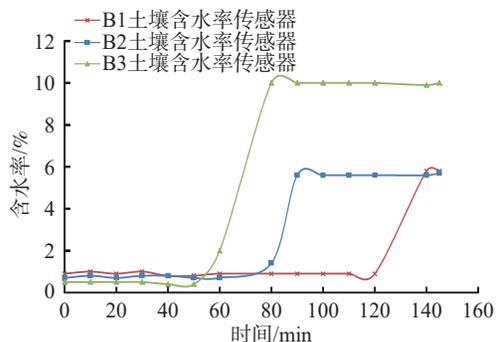
图 7 土壤含水率随降雨历时的变化规律

持续降雨条件下边坡不同位置的土壤含水率变化规律如图 7 所示。

由图 7 可知,降雨过程中,含水率持续增大,并最终趋于稳定。土体含水率随降雨历时共经历 3 个变化阶段:基本不变、加速增大和保持稳定。在降雨初期,边坡雨水入渗量较少,各个监测点的土壤含水率均无明显

变化,坡体处在基本稳定状态。随着降雨历时的增加,雨水逐渐从坡面向

坡体内部渗透,土壤含水率开始增加,降雨入渗使得土体由非饱和状态向饱和状态过渡,坡面土体遇水软化,强度降低,表面出现多处裂缝,在土体内部形成渗流通道, B2 和 B3 位置的土壤含水率处于快速增长阶段,降雨后期, B1 传感器才有明显的变化,最后土壤含水率都保持平稳状态。出现这种现象的原因是,雨水流经坡体表面,表层土体被冲刷而流失,水分子与土粒在表面形成阻碍入渗的结合水膜,土体内部气体无法排出,使得雨水难以下渗,边坡内的水分保持平衡,土壤含水率达到稳定,但此时边坡土体并未达到饱和状态。

土壤含水率明显变化的这段时间内,含水率传感器埋设位置的孔隙水压力也在迅速上升。降雨 50 min 左右,雨水流过坡面形成冲沟,坡面产生侵蚀破坏,如图 8(a)所示。B3 土壤含水率传感器开始快速增加,此时该位置的孔隙水压力也处在快速上升阶段,土体抗侵蚀性下降,坡体表面出现雨水冲蚀痕迹,发生降雨侵蚀破坏;降雨 90 min 左右, B3 含水率传感器达到最大值并保持不变,此时土体孔隙水压力也达到稳定值,不再改变,边坡上部土体侵蚀破坏范围扩大,土体稳定性降低。降雨后期, B1 传感器才开始加速上升。整个坡面的侵蚀进一步扩大,表面出现局部塌陷,如图 8(b)所示。整个降雨过程中,雨水聚集在边坡表面,流经边坡使其受到侵蚀破坏,同时在降雨过程中,坡面产生裂缝,形成渗流优势通道,更有利于雨水的入渗,使得土体含水率不断增大。

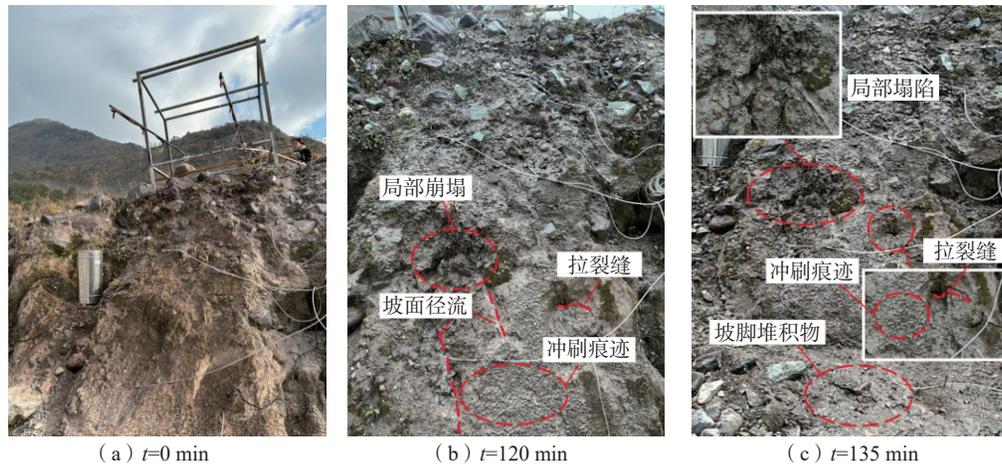
图 9 降雨过程中坡面形态图

降雨试验过程中的边坡坡面形态变化过程如图 9

所示。试验过程中,分别在持续降雨 45, 90, 135 min 三个时间点对坡面的三维形体进行扫描,获取坡面点云数

由图 10 可知,持续降雨过程中,边坡的破坏过程具体表现为:持续降雨 45 min 后,坡面出现了侵蚀破坏,雨水在坡面聚集,形成表面径流,带走坡体表面的松散颗粒。从边坡坡面变形云图可以看到,边坡表面有明显的冲刷区域,被冲刷掉的土体堆积在了坡脚。随着时间与累计降雨量的增大,试验边坡坡面破坏开始逐渐明显,坡面的冲刷痕迹不断加深,冲刷范围不断扩大,边坡上部土体流失,在边坡中部位置发生局部垮塌现象,如图 9 所示。这段时间,土体内部孔隙水压力也在迅速增大,变形破坏与孔隙水压力之间响应关系明显。降雨 120 min 后,如图 9(b)所示,边坡前缘的冲沟逐渐加深,表面出现多处拉裂缝,雨水沿着裂缝进入土体内部,边坡变形破坏范围不断扩大,此时土壤含水率陡然增加,边坡产生局部垮塌,土体内部渗透路径发生改变,

孔隙水压力开始下降。持续降雨 135 min 后,由图 10 可知,边坡表面有更多的土体流失且在坡脚堆积。从坡面形态图中可以看出,位移变化的对应位置有裂缝产生和局部小范围的塌陷,雨水的冲蚀痕迹明显,坡脚堆积土体明显增多。

由图 9 可知, 降雨 120 min 后, 边坡表面出现了侵蚀破坏和局部塌陷, 土体被雨水带走堆积在坡脚, 整体稳定性受到影响, 原因在于: 非饱和膨胀土在长时间的持续降雨作用下, 雨水入渗会使得浅表层土体孔隙水压力上升和吸力降低。孔隙水压力的升高会导致坡体滑动力增加, 且土体的有效应力下降, 边坡强度降低, 边坡坡面发生侵蚀冲刷。同时吸力下降将使得土层发生膨胀, 含有高岭石、伊利石等黏性矿物的边坡土体会因为吸水膨胀而软化, 导致土体的抗冲刷性能下降, 土颗粒之间的黏聚力随时间而降低, 在重力和雨水裹挟作用下, 导致边坡出现了多处拉裂缝, 拉裂缝的产生使得雨水进一步入渗, 雨水充满裂缝产生水压力导致边坡强度降低, 加剧边坡的破坏, 最终边坡坡面产生冲刷破坏和局部塌陷。

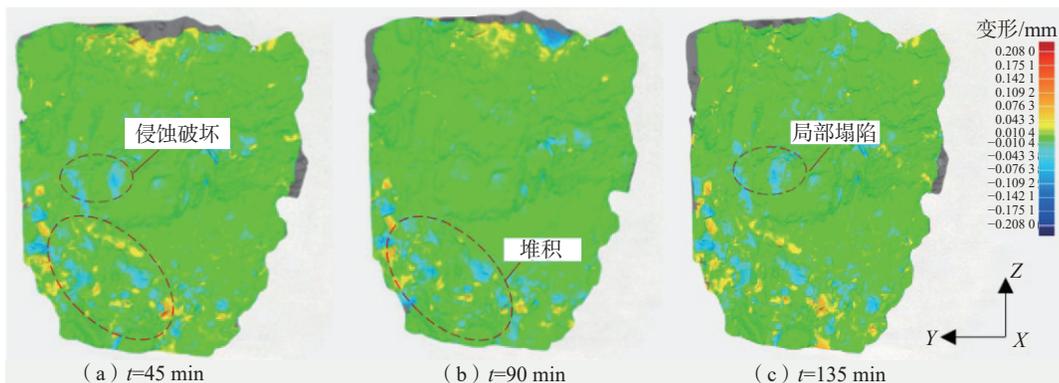
图 10 边坡坡面变形云图(负值表示冲刷,正值表示淤积)

据,经多期作差后,可以识别出边坡不同阶段的坡面三维形态变化,降雨过程中坡面形态变化云图如图 10 所示。

基于多次三维激光扫描获取的点云数据,通过计算得到本次整个降雨试验过程中边坡坡面的冲刷物源体积约为 10.0 dm^3 。

(2) 三维激光扫描结果表明: 边坡表面有明显的冲刷区域且范围不断扩大, 持续降雨导致边坡的抗侵蚀能力变弱, 土体被雨水冲刷而流失, 流失的土颗粒堆积在坡脚。整个降雨试验过程中, 边坡坡面的冲刷物源体积
