川藏铁路某特大桥成都侧岸坡工程地质特征及稳定性评价

Slope engineering geology characteristics and stability evaluation of a grand bridge to Chengdu bank on the Sichuan-Tibet Railway

DOI: 10.16030/j.cnki.issn.1000-3665.202103076

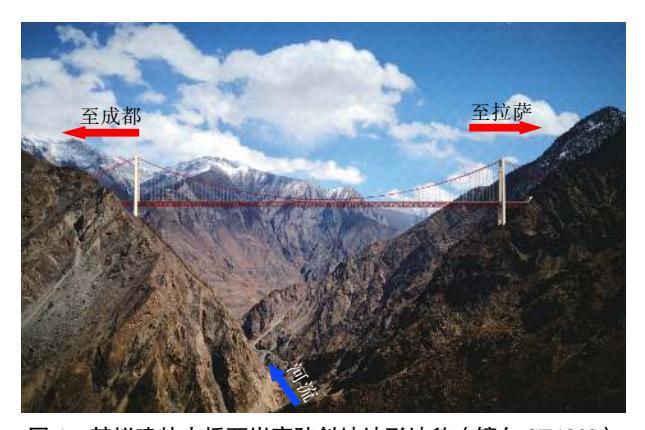
图 1 某拟建特大桥两岸高陡斜坡地形地貌(镜向 SE130°) Fig. 1 Topography of high and steep slopes on both sides of the grand bridge (photograph direction: SE130°)

川藏铁路某特大桥位于西藏自治区八宿县境内, 属于高原构造剥蚀高山峡谷地貌,河谷区为典型的 "V"字型河谷(图1),桥面标高3650m,桥位区江水位 高程约3040m,桥面距离江水位高差超过600m。特 大桥两岸斜坡山高坡陡,地形险峻,地形总体呈下陡 上缓趋势,其中斜坡中下部整体地形坡度超过40°,斜 坡浅表部岩体中裂隙发育,岩体完整性遭到破坏,岩 体结构较差,发育多个危岩体。

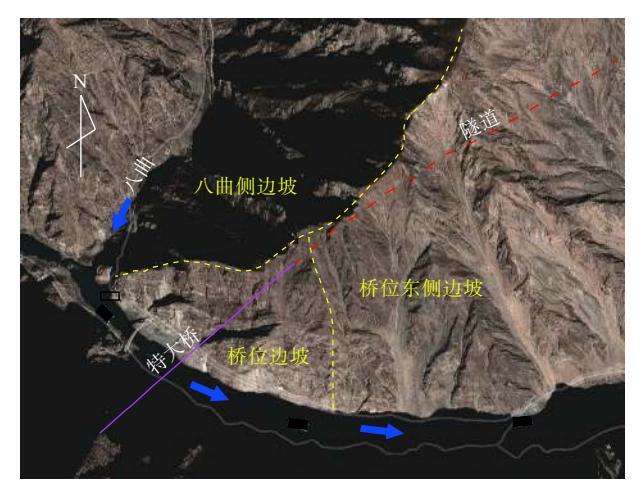
图 2 成都侧岸坡分区图 Fig. 2 Zoning characteristic of bank slope to Chengdu

结合现场调查和遥感影像可知,成都侧岸坡受河 流和冲沟的联合切割作用,形成斜坡南侧、西侧均临 空的地形。根据斜坡地形、地质特点以及桥梁布置方 案,可将成都侧岸坡划分为桥位边坡、八曲侧边坡和 桥位东侧边坡(图 2)。

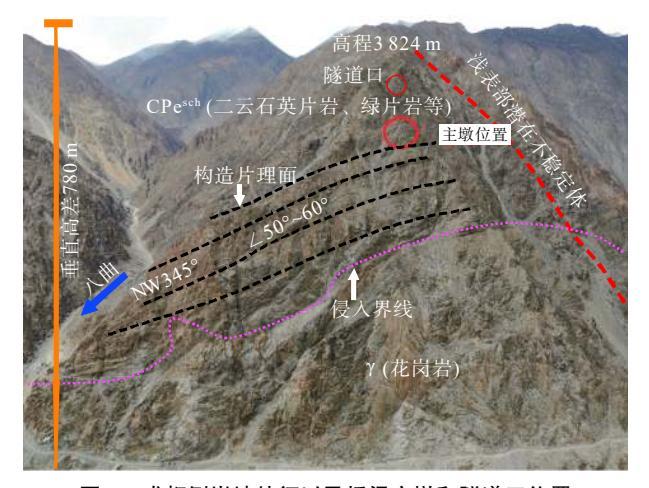
图 3 成都侧岸坡特征以及桥梁主墩和隧道口位置 (镜向 NE50°)

Fig. 3 Characteristics of bank slope to Chengdu and location of the main bridge pier and entrance of tunnel (photograph direction: NE50°)

面临空的状态。地质调查发现,八曲侧斜坡从主河与 八曲交汇口往八曲上游方向发育3个陡崖和4个缓 坡,分别为一级陡崖、二级陡崖、三级陡崖。陡崖发 育于各级坡面之间,高20~100m,主要沿着陡倾结构 面发育而成。缓坡则分别命名为一级斜坡、二级斜 坡、三级斜坡和四级斜坡。八曲自北向南流,但从第 三级斜坡时开始偏转:第三级斜坡上游,八曲河谷走 向与片理面倾向夹角约75°,大角度相交;第三级斜坡 下游,八曲河谷走向与边坡片理面倾向夹角约25°~ 40°,小角度相交,局部为顺层斜坡(图3)。

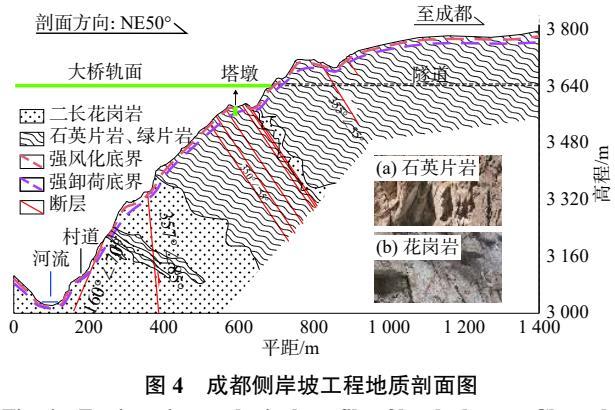
野外地质调查和钻孔、平硐揭露,特大桥成都侧 岸坡岩性较为复杂,地层岩性主要有2类:斜坡上部 为石英片岩、绿片岩等,斜坡下部为二长花岗岩、花 岗闪长岩(图4)。其中斜坡上部石英片岩、绿片岩主 要由三组岩性组成,分别是怒江岩组、惜机卡岩组和 俄学岩组。怒江岩组为一套灰白色绢云石英片岩、云 母片岩、黑云石英片岩等夹变火山岩岩块。惜机卡岩 组主要为一套二云石英片岩,下部夹变流纹岩,上部 夹大理岩岩块。俄学岩组以碳酸盐化超基性岩与惜 机卡岩组断层接触,随后变为强变形泥质板岩及钙质 板岩等。

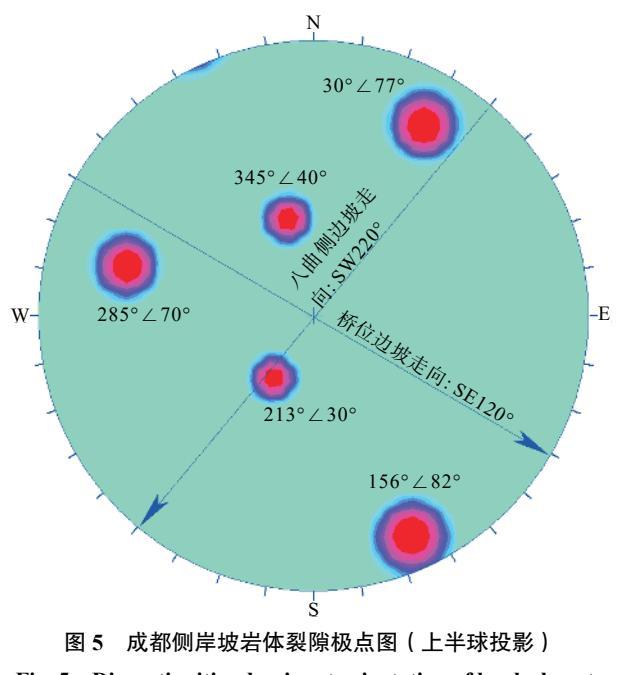
Fig. 5 Discontinuities dominant orientation of bank slope to Chengdu (upper projection)

受区域构造以及斜坡岩体风化卸荷影响,特大桥 成都侧岸坡浅表部岩体破碎,结构面发育。地面调查 以及勘探平硐揭露,位于斜坡浅表部的结构面普遍张 开,张开宽度1~3mm,最大可达3~5cm,充填少量 岩块、岩屑和夹泥。勘探平硐内结构面可见迹长普遍 在30~80cm之间,少量结构面贯穿平硐壁和洞顶。 地质调查结合平硐资料揭示,斜坡岩体中主要发育 5组优势结构面(图5):①285°∠70°,相对桥位边坡陡 倾坡内,相对八曲侧斜坡陡倾坡外;②345°∠40°,相 对桥位边坡和八曲侧斜坡均为中陡倾坡内;③213°∠ 30°,相对桥位边坡中倾坡内,相对八曲侧斜坡陡 倾坡内;⑤156°∠82°,相对桥位边坡和八曲侧斜坡陡 倾坡内;⑤156°∠82°,相对桥位边坡和八曲侧边坡均 为陡倾坡外。

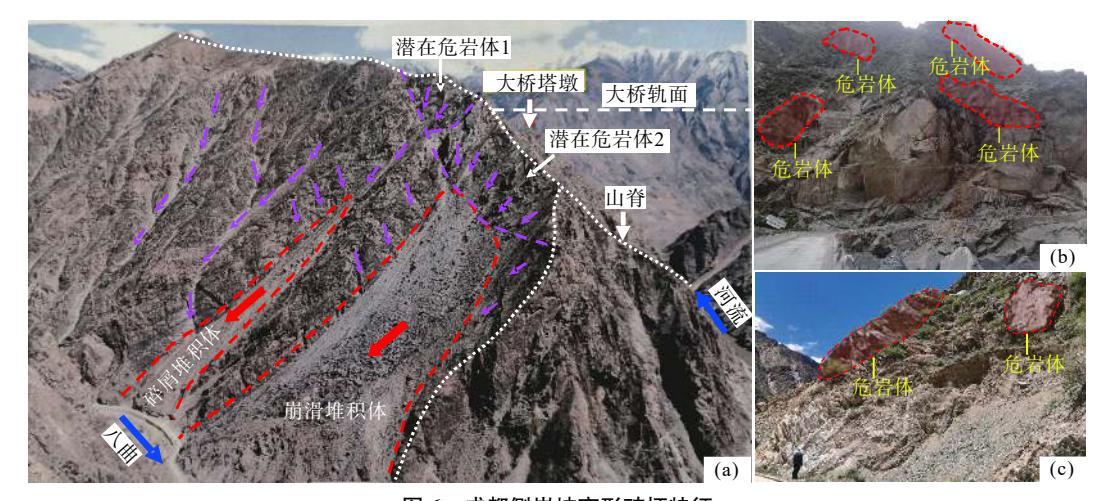
性差。野外地质调查发现成都侧岸坡浅表部发育多 处危岩体(图 6),存在崩滑、落石、滚石等威胁桥梁和 桥基工程安全的隐患。另外拟建桥位上游发育八曲 冲沟,其中左岸(靠拟建桥墩一侧)为顺层斜坡,该斜 坡历史上曾发生多次较大规模滑动,目前在斜坡中下 部仍堆积有最大厚度达 60 余米的崩滑堆积体,在斜 坡顶部发育 2 处较大规模潜在危岩体,如图 6(a)所 示。根据设计资料,特大桥成都岸主桥墩距离斜坡顶 部山脊仅 40~50 m,一旦八曲侧斜坡在地震等工况下 再次发生较大规模顺层下滑垮塌,可能直接破坏或摧 毁大桥桥墩,从而影响特大桥以及整个川藏铁路的安 全运营(图 7)。

①顺层滑移破坏,主要发育在八曲侧顺层斜坡。 这类破坏主要受层间弱面影响控制:斜坡岩体顺层间 弱面蠕变变形,当变形达到一定程度后,受降雨、地震 等外界扰动,斜坡岩体突然发生顺层间弱面的下滑破 坏,如图 6(a)所示。

②坠落式破坏,主要发育在桥位边坡,规模一般 小于 10 m³。这类破坏主要受多组结构面切割以及强 烈卸荷拉张裂隙影响控制,如图 6(b)所示。

③倾倒式破坏,在桥位边坡和桥位东侧边坡均有 发育,规模一般从几立方米至上百立方米不等。这类 破坏和岩体结构、坡体结构以及与临空面的组合关系 密切相关,主要是部分层状或似层状岩体在长期的重 力作用下发生向临空面的弯曲变形破坏,如图 6(c)所示。

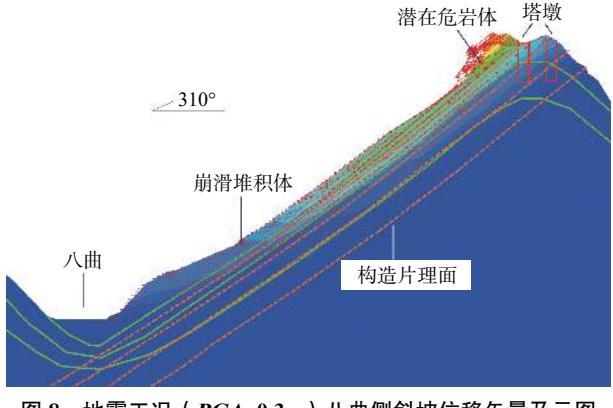
采用 PHASE 软件进行数值计算,结果表明:强震 工况下八曲侧斜坡中上部强风化岩体出现明显位移 变形趋势,特别是在斜坡顶部的危岩体出现向临空面 和斜坡下方较大的位移量,斜坡岩体存在顺构造片理 面下滑破坏趋势(图 8)。

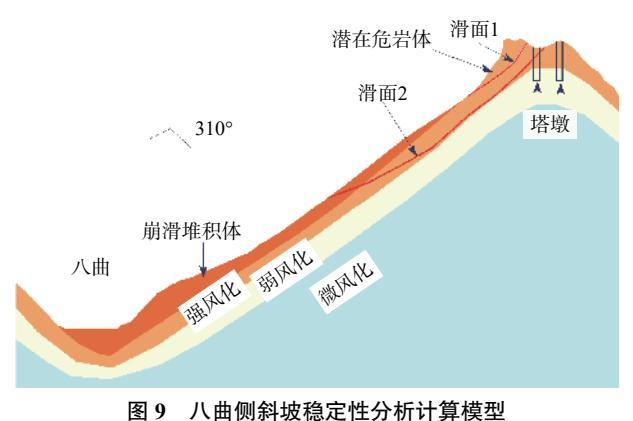
根据数值分析结果,结合八曲侧斜坡地质结构和 变形破坏模式、边界条件等,建立相应的刚体极限平 衡法计算模型,如图9所示。计算模型中一共设置 2个潜在非圆弧破裂下滑面,分别为滑面1和滑面2: 滑面1对应的下滑体是斜坡顶部潜在危岩体;滑面 2对应的下滑体是强风化、强卸荷带内潜在的顺层滑 动破坏。

稳定性计算采用商用软件 slide, 计算模型中的材 料分别有堆积体、强风化岩体、弱风化岩体、微风化 岩体以及强风化和弱风化岩体中的顺层片理面。计 算参数参考铁路系统专题报告给出的各类材料物理 力学参数, 具体见表 1。计算工况见表 2。

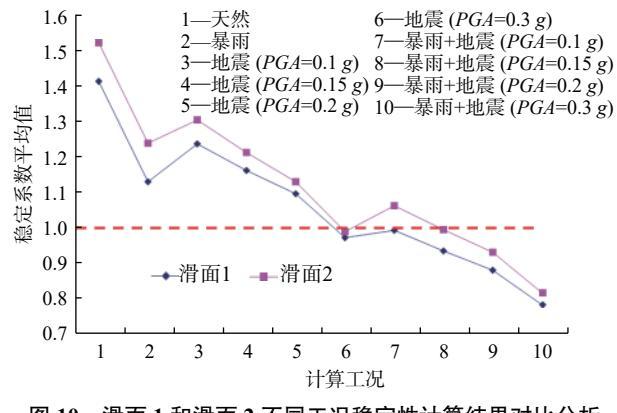
图 10 滑面 1 和滑面 2 不同工况稳定性计算结果对比分析 Fig. 10 Stability calculation results of sliding surface 1 and sliding surface 2 under different conditions

根据表 2 的计算结果,将 5 种方法计算得到的稳定系数(FOS)的平均值与计算工况置于同一个坐标系中进行分析,如图 10 所示。总体而言,在相同工况条件下,滑面 1 对应的潜在滑坡体比滑面 2 对应的潜在滑坡体稳定系数稍低,意味着相同工况条件下,八曲侧斜坡顶部危岩体稳定性比强风化、强卸荷带内顺层面滑动体稳定性低一些,这与实际调查情况吻合。另外当斜坡遭遇强烈地震时(PGA≥0.3 g),八曲侧顺层岩质斜坡,特别是斜坡顶部潜在危岩体可能出现较大规模失稳破坏,威胁特大桥塔墩以及火车的安全运行。
