西藏波密茶隆隆巴曲高位地质灾害类型及发育特征

摘要:茶隆隆巴曲位于帕隆藏布右岸,陡变地形孕育了大量高位地质灾害,威胁下游线性工程。采用多源、多期次高分 辨率遥感数据,建立高位地质灾害遥感解译标志,厘定了研究区高位地质灾害类型,并详细阐述了其发育特征。结果表 明,研究区主要地质灾害类型包括高位冰崩、高位崩塌、高位滑坡。其中高位冰崩发育3处,均位于沟谷上游南坡海拔5000m 斜坡,面积在15×10⁴ m²以上。高位崩塌体发育19处,多分布于沟谷中游及上游主沟两侧高陡岸坡,北坡多于南坡。高位 滑坡发育2处,位于沟谷上游,滑体以冰碛物为主。上述高位地质灾害在强震或强降雨作用下,极易发生失稳、堵沟,且 堵沟后极易诱发洪水、泥石流等次生灾害链,对下游帕隆藏布造成堵江风险。

Types and development characteristics of high geological disasters in Chalonglongbaqu gully, Bomi, Tibet

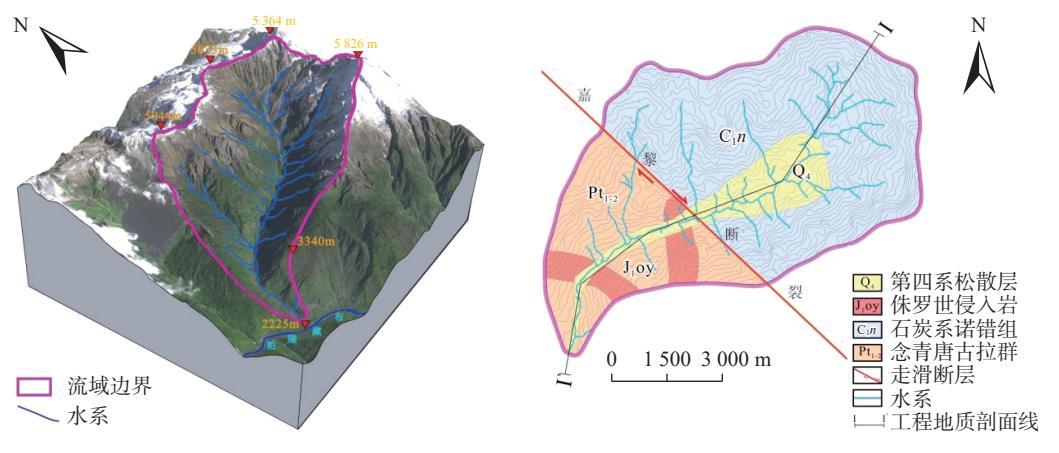
图 1 研究区三维遥感地形 (左)及地层岩性分布图 (右)

研究区地处一级构造单元岗底斯-喜马拉雅造山 系,东构造结北缘,构造活动十分强烈。受板块挤压活 动,区内地面发生强烈隆升,发育一系列北西向断裂。 其中嘉黎断裂带横穿研究区,断裂走向 NW 60°—70°, 倾向不定,是影响研究区斜坡稳定性的一条重要活动断 裂带。断裂长期活动造成近断裂带附近岩体结构面十 分发育,岩体破碎,不利于斜坡稳定。从流域水系分布 来看(图 1), 流域呈树枝状, 主沟沟长 10.38 km, 与帕隆 藏布的交汇口海拔为 2 225 m, 流域内最高点海拔 5 826 m, 最大高差达到 3 601 m, 平均坡度可达 34.7°, 陡 坡主要位于主沟、冲沟两侧。另外,主沟上游与下游横 剖面形态特征不一,上游段呈"U"型、下游段呈"V" 型。"U"型河谷一般为冰川运动所成,为上部物质堆积 提供了有利空间。而"V"型谷往往由河流下切而成,这 种形态有利于形成强劲的水动力条件。研究区出露元 古界、石炭系地层以及第四系松散堆积层(图1)。

Fig. 1 Three-dimensional remote sensing topography (left) and stratum lithology distribution map (right) of the study area

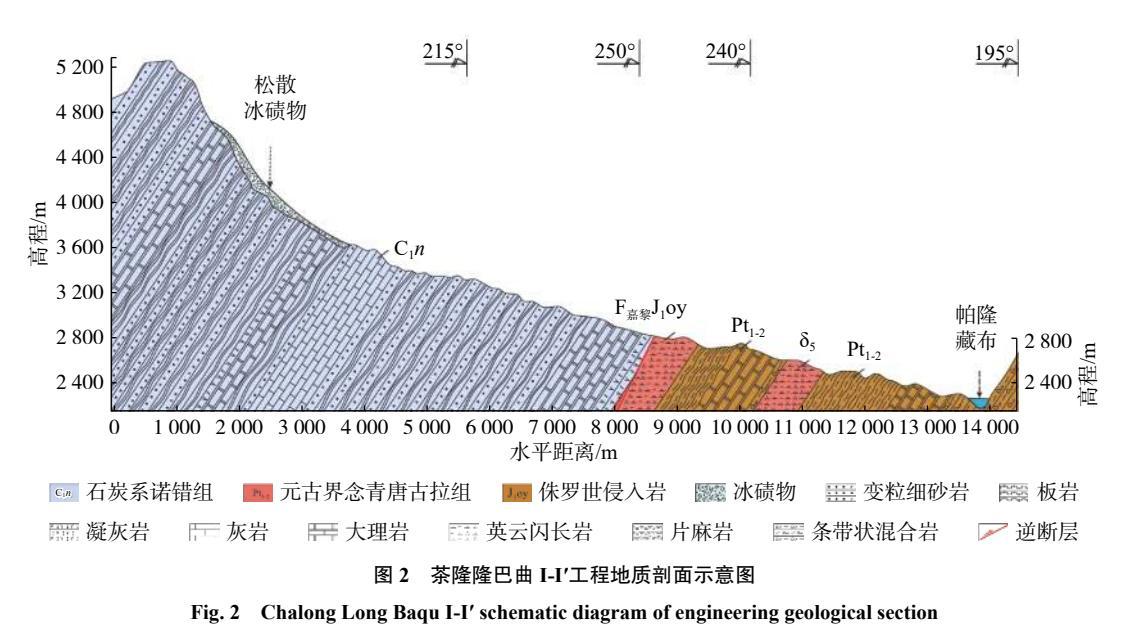
图 2 为茶隆隆巴曲工程地质剖面图,流域上游坡度 整体在 40°以上,为冰雪覆盖区,岩性为诺错组大理岩、 灰岩,夹少量变砂岩、板岩、凝灰岩,地表径流作用强, 易形成强水动力条件。高位崩滑形成大量冰碛物堆积 于斜坡之上,易引发二次滑动。中下游整体坡度在 20°以下,可见念青唐古拉岩群地层,岩性以英云闪长岩 为主,岩体表面风化强烈。该段坡度小,有利于两岸岸 坡崩滑体碎屑、剥蚀等松散物质堆积以及降雨、冰川融 水聚集,为泥石流物源提供了良好的储藏及运移通道。 综上可得,研究区地形陡变、构造活动强烈,具备良好 的孕灾地质条件。

宽缓部位的冰碛物失稳后向下滑动的这一地质现象,发 育高程多超过4000m,与河谷高差一般大于500m(图2)。 其中 HP1 滑坡面积约0.36 km²,植被覆盖较周围稀疏。 这些冰碛物易在地震、降雨等因素作用下失稳滑动,也 易受上部其他高位地质灾害所激发转化成为泥石流地 质灾害链(图3)。部分冰川谷中的冰碛物体积巨大,一 旦从高位滑落,威胁范围广泛且存在一定的堵江风险。

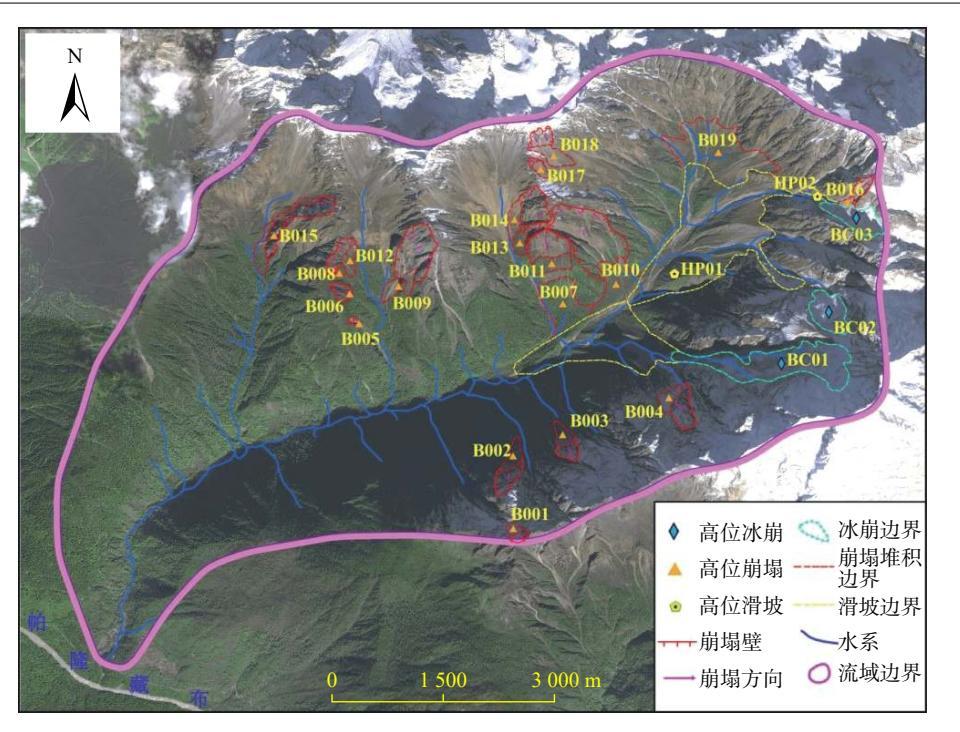
图 3 研究区高位地质灾害分布图 Fig. 3 Distribution map of high-level geological disasters in the study area

根据高分辨率遥感解译结果,研究区共发育高位地 质灾害 24 处。其中高位冰崩 3 处,分布于主沟南侧海 拔 5 000 m 以上极高山地区。高位崩塌 19 处,多数位 于主沟北侧,少数沿上游主沟左岸高陡斜坡处分布。高 位滑坡 2 处,分布于上游宽谷岸坡。

由于研究区海拔高程大、植被发育、发生地点偏远 且难以接近,人工地面调查对灾害的识别难度大。而借 助高分辨率遥感影像,能够快速、准确的进行灾害识 别。本文收集了研究区 2013—2020 年 7 年间资源三 号、高分一号、Google 地球、无人机影像等多源遥感数 据,数据分辨率有中低分辨率 8 m,也包括中高分辨率 2.0 m、0.2 m(图 3)。遥感数据主要用于:①研究区高位 地质灾害精细化解译;②研究区高位地质灾害光学遥感 特征分析(表 1)。

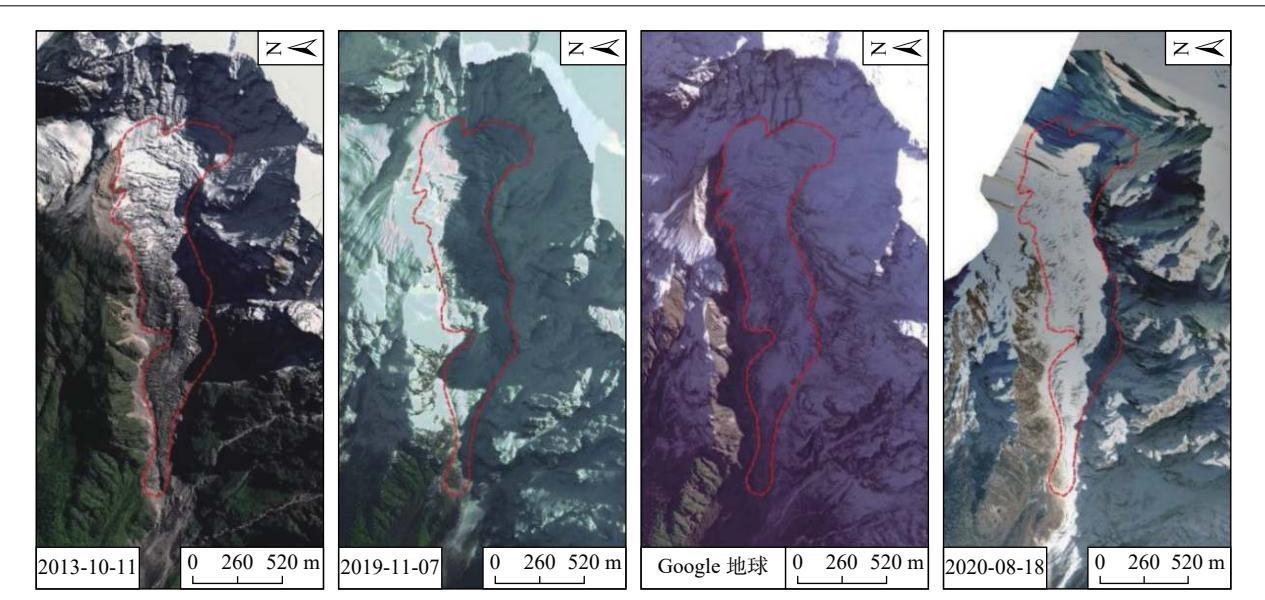
图 4 BC01 冰崩堆积体多期光学遥感解译

约 72.0×10⁴ m², 总面积达 1.11×10⁶ m²。冰川前缘高程在 3 600~4 500 m, 后缘高程在 4 800~5 200 m, 高差约 400~1 500 m, 后缘距离沟口约 2 600~3 000 m(表 2)。 其中, BC01 冰崩堆积体面积约 0.72 km², 距离沟底的最 大高程落差达 2 km, 积雪较多。从高分辨率遥感影像 上来看, 表面横向裂缝发育, 影像上呈黑色条线状(图 4)。

这些横向裂隙的发育将冰川切割成多个局部连通的块体,部分块体在重力等作用下已发生崩落。但在极端工况下,该冰崩堆积体可出现冰崩,对下游将造成严重威胁。

Fig. 4 Multi-phase optical remote sensing interpretation of BC01 ice avalanche deposits

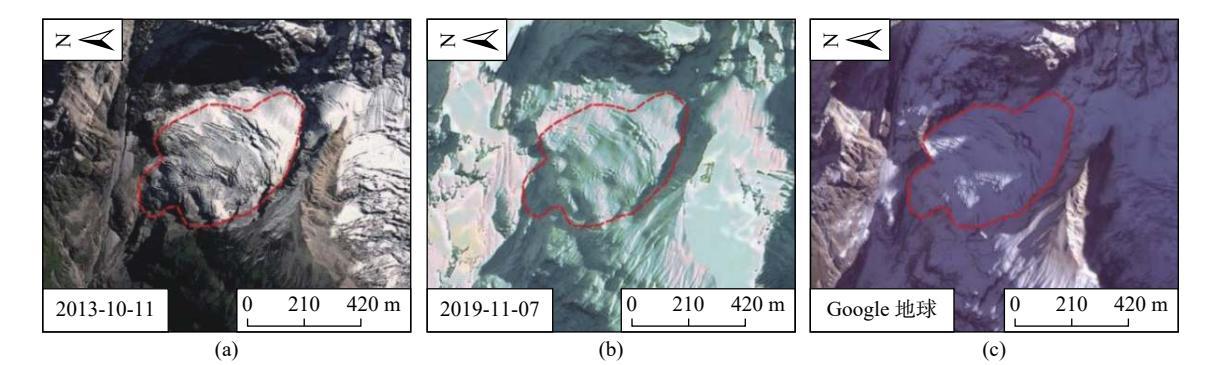
图 5 BC02 冰崩体多期遥感影像

BC02 冰崩堆积体位于 BC01 冰雪堆积体附近,其 表面特征与上述 BC01 冰崩堆积体类似,可见拉裂缝条 纹。对比冬季和夏季的影像数据,发现该处由于地处阴 面坡的沟谷,受冰川冻融作用较小,坡体变形以下部变 形后牵引上部冰川产生拉裂为主(图 5)。侧部边缘裂 缝也出现局部的闭合趋势,整体处于欠稳定状态,极端 条件下可出现冰岩崩现象。

Fig. 5 Multi-phase remote sensing image of BC02 ice avalanche

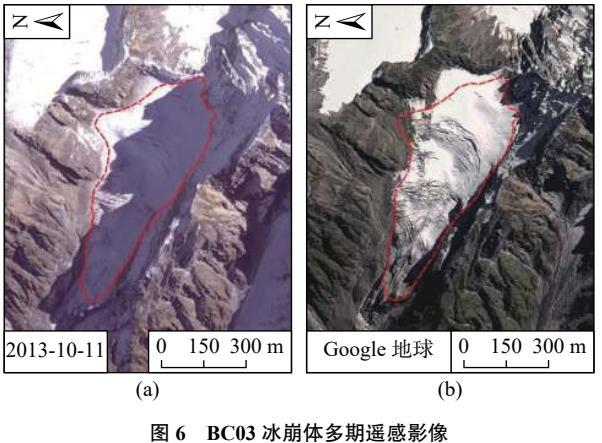
BC03 冰崩堆积体距离沟口较远,长期有积雪覆盖, 积雪表面可见明显的横向裂隙。图 6 展示了该处 10 月 的影像,从中可以看出周边岩体上的积雪已经消融,故 推断该处沟谷较深且积雪量相对较大。但考虑到该堆 积体位于沟谷深处,距离沟口较远,整体影响有限。

Fig. 6 Multi-phase remote sensing image of BC03 ice avalanche

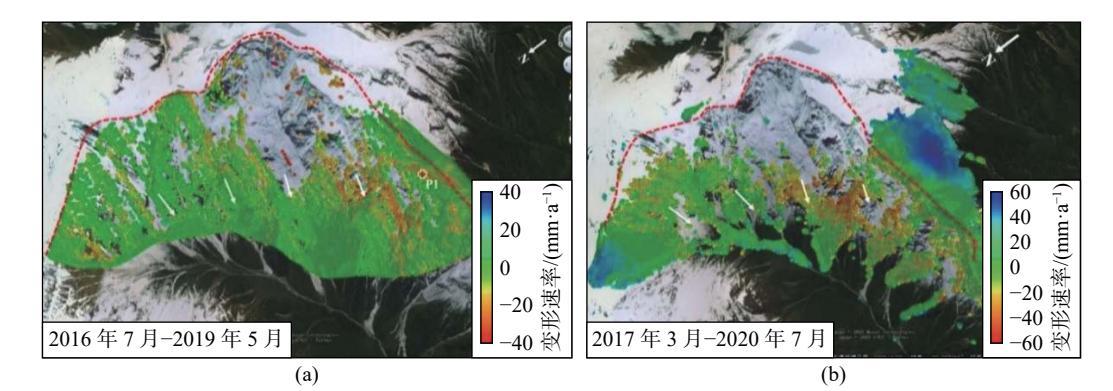
基于升轨 ALOS/PALSAR-2 及降轨 Sentinel-1 数据,利用 Stacking-InSAR 技术获取了冰崩区年均地表形 变速率,其中升轨 ALOS/PALSAR-2 数据获取时间为 2016 年 7 月—2019 年 5 月,结果如图 7(a)所示。降轨 Sentinel-1 数据获取时间为 2017 年 3 月至 2020 年 7 月,结果如图 7(b)所示。从图 7 可以看出以上三处冰崩区 区域坡顶由于冰雪覆盖等因素造成地表失相干现象, InSAR 未能获得有效监测点,冰崩体中部存在明显形 变,最大 LOS 向年均形变速率分别达到-40 mm/a 和

-60 mm/a, 表明该冰崩体部分区域存在变形。

Fig. 7 InSAR deformation rate diagram in the ice avalanche zone

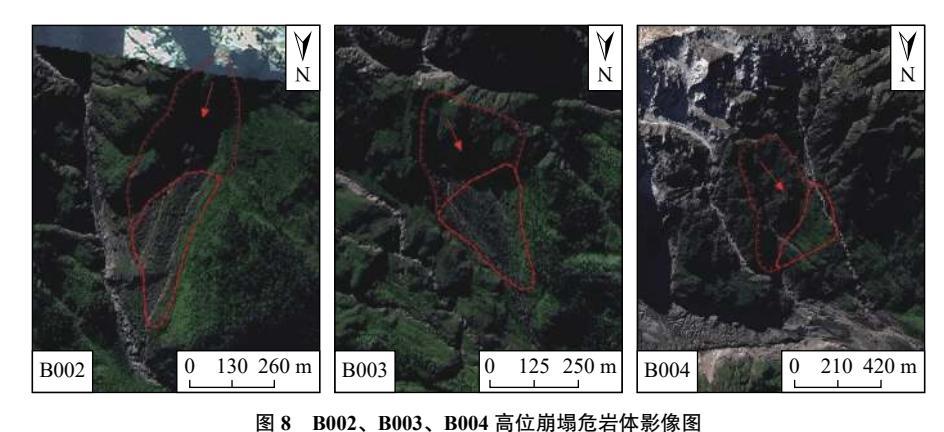
成南北岸坡灾害发育不一的原因可能是北坡处于阳面, 冰雪冻融作用强,岩体力学性质劣化速率大于南坡,故 造成北坡崩塌危岩体较南坡发育。其中 B002、B003、 B004 高位崩塌位于南坡,坡向朝北,距离沟底落差多在 1000~1500 m,势能大、坡度陡,表面常年积雪覆盖 (表3)。从规模上来看,该三处高位崩塌体体积大,临 空条件好,少量植被发育或无植被,表面可见一条或多 条支沟发育。局部岩体出露良好,结构面发育,沟内碎 石堆积(图 8)。极端条件下,发生岩崩和雪崩可能性 大,易对主沟形成堵塞,其物质为泥石流提供物源,对下 方沟谷造成威胁。

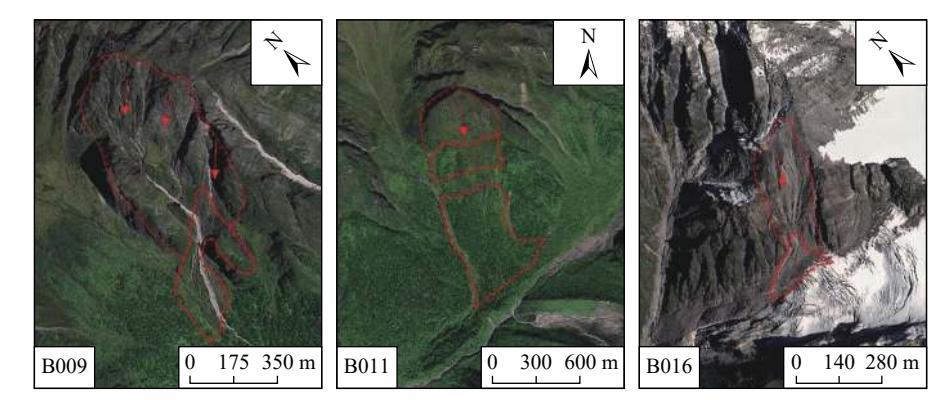
图 9 B009、B011、B016 高位崩塌危岩体影像图 Fig. 9 Image of dangerous rock masses of B009, B011, and B016 high-level collapse

B009、B011、B016 高位崩塌位于沟谷中游及上游, 距离沟底落差在880~1100 m,均位于北部岸坡(表3)。 其中 B009、B011 岩体出露良好, 植被不发育, 左侧发 育1~2条冲沟,且坡陡、落差大,为崩塌体灾害的孕育 提供了良好的临空条件。从影像上来看,岩体表面可见

多组结构面发育,这些结构面与坡面耦合形成多个易滑 结构体,在外动力作用下下,进一步演化成危岩体(图 9)。 B016高位崩塌位于南坡上游近山顶处,高程接近 5000 m,其下部发育一条冲沟,具有良好的临空条件。 从夏季遥感影像可知,岩体表面无植被覆盖,右侧边缘 痕迹明显,疑似崩塌侧壁,而下半部分岩体可见沿坡向 发育密集分节理(图 9)。另外,北坡位于阳面,冻融作 用强、岩体力学性质劣化速率快,极端工况下 B016 危 岩体崩落可能诱发 BC03 冰崩、雪崩等次生地质灾害。
