井--孔联合疏排高填方滑坡地下水典型案例分析

Analysis of typical cases of groundwater in high fill landslide with combined well-hole drainage

赖国泉, 焦海平. 井-孔联合疏排高填方滑坡地下水典型案例分析[J]. 中国地质灾害与防治学报, 2024, 35(4): 106-114. LAI Guoquan, JIAO Haiping. Analysis of typical cases of groundwater in high fill landslide with combined well-hole drainage[J]. The Chinese Journal of Geological Hazard and Control, 2024, 35(4): 106-114.

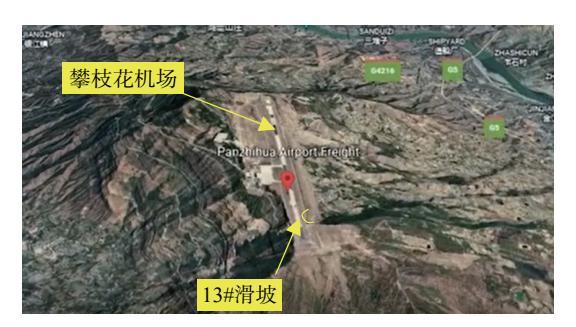
图 1 地形地貌 Fig. 1 The topography and landform

研究区为中山丘陵、山区峡谷地貌,见图 1。受区 域地质构造及机场建设等因素影响,地形起伏变化较 大,高差悬殊大。机场建设前整体为一走向 N—S 向条 形山脊。机场建设后东侧填筑形成高填方区,高达八 级,最大高度 66 m^[14]。

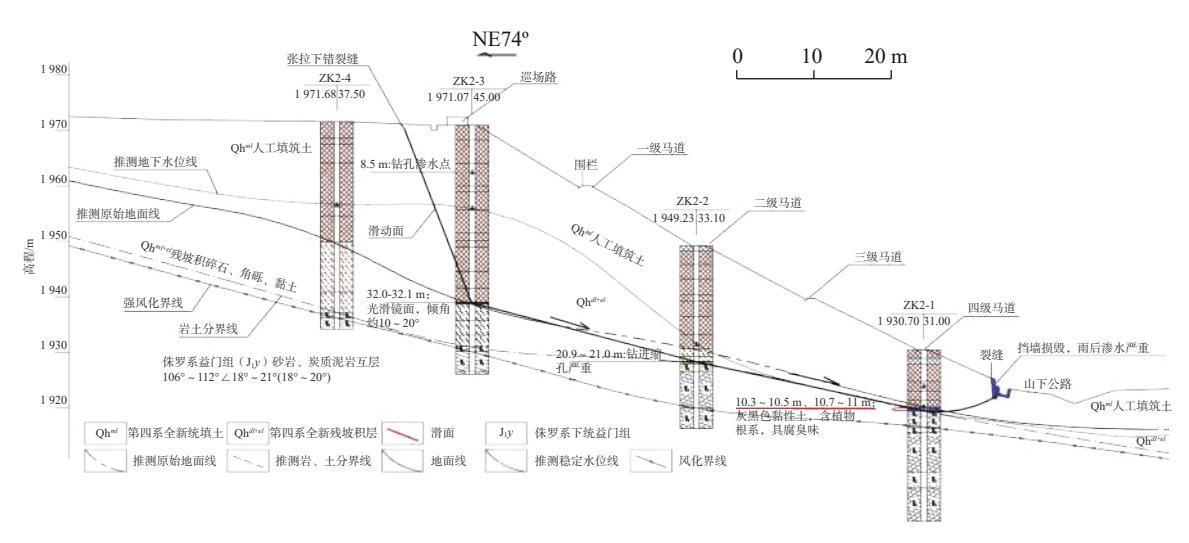
钻探揭露研究区地层自上至下为第四系人工填土 层(Qh^{ml}),母岩以强风化砂岩、炭质泥岩角砾、碎石为 主,黏土充填,最大厚度达 33 m。第四系全新统残坡积 层(Qh^{el+dl}),主要为角砾土、碎石土,黄褐—灰褐色,黏 土充填,含水量较高,呈可塑—坚硬状,层厚度变化较 大,最大可达 12 m。下伏侏罗系下统益门组(J₁y)炭质 泥岩、砂岩,缓倾互层状产出,岩层倾向与坡体倾向相 近,倾角 18°~21°。典型工程地质断面图见图 2。

图 2 典型工程地质断面 Fig. 2 The typical engineering geology cross-section

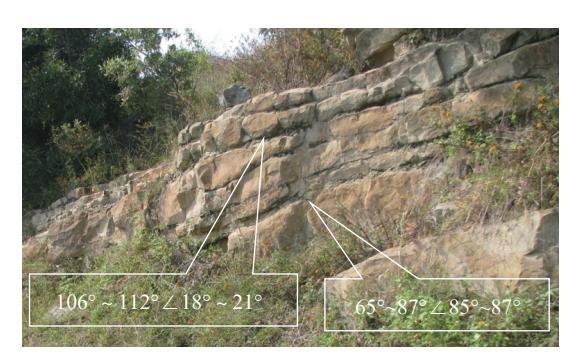
斜东北翼, 地层产状 106°~112°∠18°~21°, 见图 3。岩 层中发育有两组张节理, J1 节理: 65°~87°∠85°~87°, 间

距 3~5 m, 闭合—微张开; J2 节理: 264°~280°∠82°~86°, 间距 5~15 m, 闭合—微张, 两组节理均黏土或硅质充填。

图 3 坡脚基岩露头 Fig. 3 Outcrop of bedrock at the slope toe

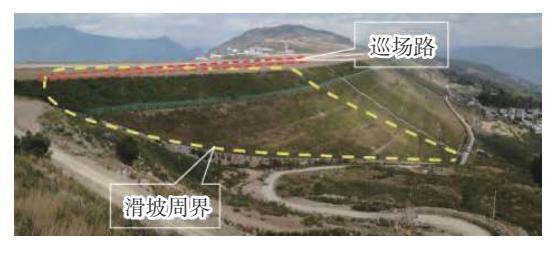
该滑坡平面形态呈"簸箕"状,见图 4。且前缘不对称。滑坡纵向长约 162 m,横向宽约 246 m,后缘至剪出口高差最大 68 m,钻孔揭露滑体最大厚度 32.3 m,滑体总体积约 50.42×10⁴ m³,为一大型填筑体滑坡。

图 4 滑坡全貌^[14] Fig. 4 Overall view of the landslide^[14]

该滑坡周界清晰,后缘位于土面区张拉下错裂缝 处,裂缝走向 NE24°—NE33°,与巡场路(坡口线)走向 基本一致。左侧界依附于巡场路至一级马道处剪切裂 缝,走向 SW21°—SE33°滑坡右侧以巡场路张开裂缝北 端至五级马道截水沟沟壁外倾变形段为界。滑坡剪出 口在坡体南侧沿坡脚便道、截水沟沟底展布,至五级马 道截水沟倾倒损毁处沿该平台向北延伸。

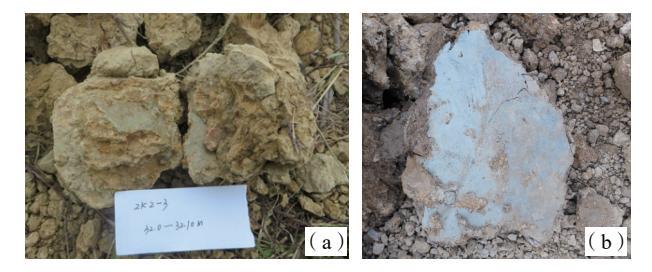
该滑坡发育有一层滑带(面), 主滑段滑动带(面)依 附于全风化残、坡积层。滑带土以残坡积层中灰白色 黏土夹层为主, 含水量高, 呈软塑状, 泥膜呈灰白色, 滑 面泥膜处可见明显粗粒土擦痕, 见图 5。揉皱严重, 倾 角随滑面位置的不同而略有变化, 主滑段滑面倾角 12°~17°滑面埋深最大达 32.3 m, 横向呈中间深、两侧 浅, 在南、北两侧受老地面控制。

图 5 钻孔(a)、桩坑(b)中揭露滑面 Fig. 5 Exposed sliding surfaces in boreholes (a) and pile pits (b)

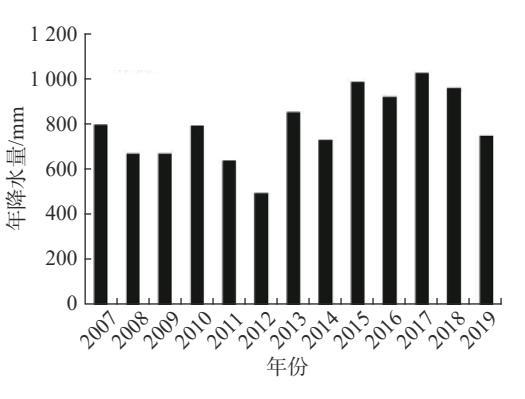
图(图 6)可知,研究区年平均降水量为 792 mm,年最大 降水量发生于 2017年,为1025.2 mm。年最小降水量 发生于 2012年,为496 mm。年平均降水天数 97 d。由 图 7可知,研究区雨季为 5—10月,平均降水量为 737.16 mm,占全年降水量的 95%。前汛期(5—7月) 多年平均降水量为 385.13 mm,占雨季降水量的 52%。 后汛期(8—10月)多年平均降水量为 352.03 mm,占 雨季降水量的 48%。旱季 6 个月,年平均降水量仅为 54.84 mm,仅占全年降水量的 5%。以上数据充分说明 滑坡区雨季降雨集中,降雨强度大。

图 6 2007—2019 年年降水量分布图 Fig. 6 Distribution map of annual average rainfall from 2007 to 2019

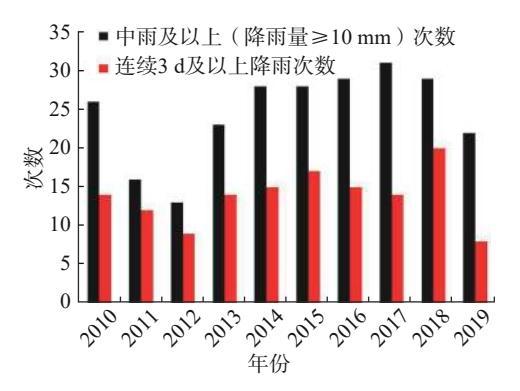
持续降雨之后。攀枝花机场每年均出现大量中—暴雨 及持续降雨,对机场降雨数据的详细统计分析后,得到 了 2010—2019 年每年中雨及以上出现次数及每年连 续 3 d 出现降雨次数,具体见图 8。由图 8 分析可知,按 日均降水量标准计算,中雨(10~25 mm)、大雨(25~ 50 mm)及暴雨(≥50 mm)出现次数,年平均为 24.5 次, 每年平均连续 3 d 及以上出现降雨天数为 14 次。中— 大暴雨、3 d 及以上出现降雨天数出现次数集中于雨季 7—9月,占总数的 95% 以上。充分说明滑坡区降雨具 有雨季降水量强度大且集中的特点。

图 8 2010—2019 年中雨及以上次数、连续 3 d 降雨次数分布图 Fig. 8 Distribution map of the frequency of moderate rain or more for consecutive 3-days rainfall events from 2010 to 2019

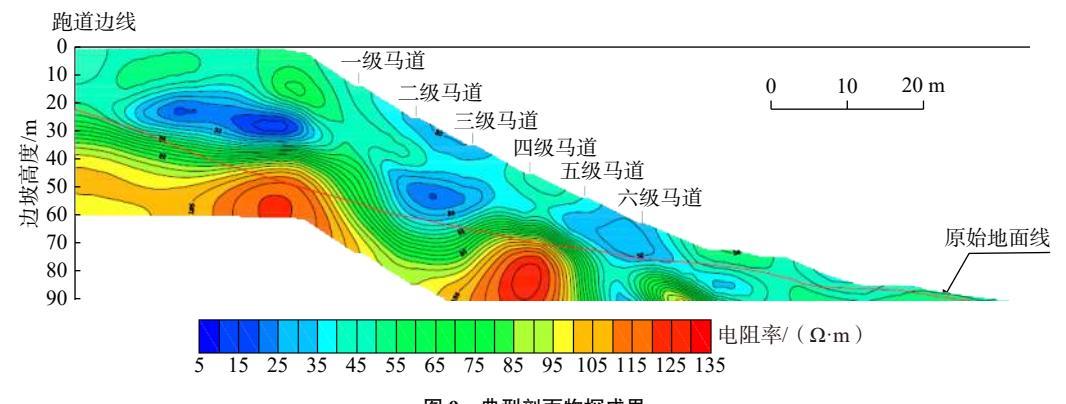
物探成果(图 9)表明, 二级马道以上至场坪土面区 地段电阻率明显偏低, 说明该处为滑坡体主要富水区 域, 具有"窝"状不连续分布特征, 具有明显的成层性。 通过钻孔中含水层段岩芯分析表明, 含水层具有黏土含 量高、赋水性较好、孔隙连通性差、径流不畅, 坡内水 难以快速消散等特点。孔隙潜水分布于基岩顶面原始 地层中。现场调查, 填筑体 4 级、5 级马道平台截水沟 及坡脚挡墙损坏段可见地下水渗出, 见图 10。坡脚鱼 池处可见基岩与覆盖层界限处亦有地下水渗出。主要 受上游降雨入渗、浅层基岩裂隙水沿层面运移及上层 滞水沿隔水底板边缘下渗补给, 沿基岩顶面向下游径流 至鱼塘排泄。

图 9 典型剖面物探成果 Fig. 9 Typical section geophysical survey results

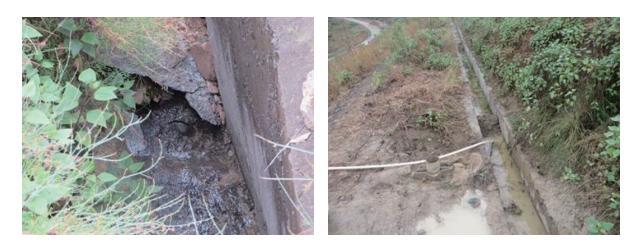
图 10 坡脚、平台水沟地下水出露 Fig. 10 The underground water emergence from slope foot, platform ditch

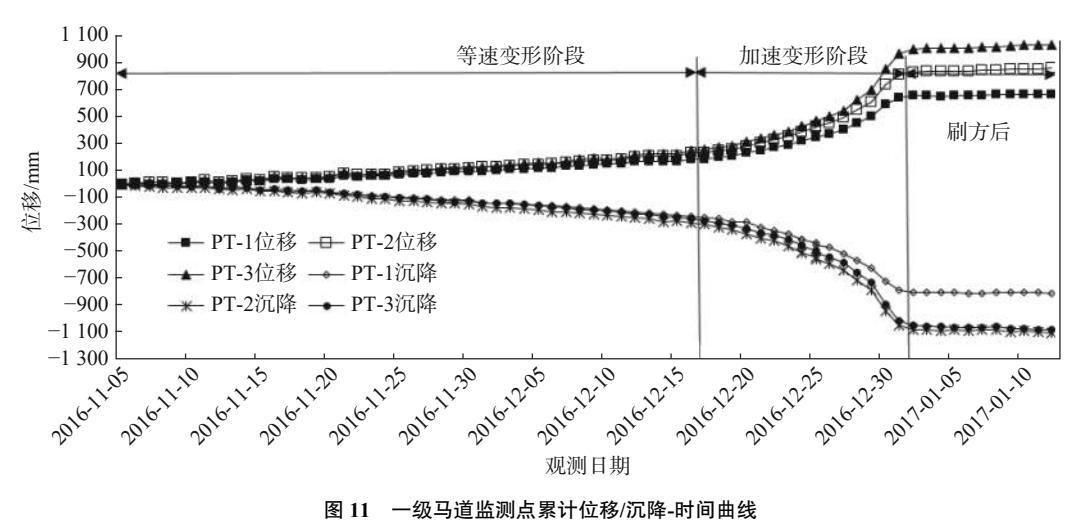
该滑坡自发现地表宏观变形迹象,立即采取地表变 形监测。典型位移/沉降—时间曲线见图 11。由图 11 分析表明,坡体处于等速变形阶段,且变形发展迅速。

Fig. 11 Cumulative displacement/settlement - time curve of level 1 monitoring point

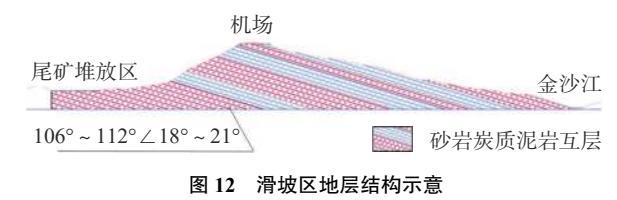
该滑坡发育在斜坡上填筑的超高(最高达 68 m)填 筑体边坡上。填筑体下伏基岩为缓倾顺层侏罗系炭质 泥岩、砂岩。研究区地层结构示意见图 12。由图 12 分 析可知,受特殊的上软下硬单斜顺倾坡体结构影响,使 地下水向同一个方向的汇集具有了沿层面渗流的条件, 基岩中发育的两组张性节理,形成了基岩中的裂隙水 渗流通道,使得基岩裂隙水从机场西侧甚至机场山梁西 侧直接进入滑体有了地下通道。机场填筑边坡时,由于 底部及填筑体内设置的排水措施偏少,地下水不能及时 排除。

Fig. 12 Schematic diagram of strata structure in the landslide area

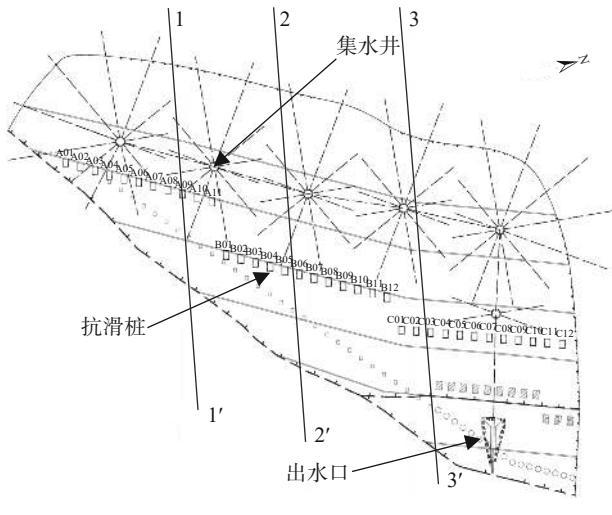
永久工程治理方案采用支挡工程与排水工程相 结合的方式进行。支挡结构根据滑坡推力大小,采用 普通抗滑桩、预应力锚索抗滑桩强支挡。地下排水结 构措施采用集水井联合井内仰斜排水孔疏排地下 水。具体工程平面布置图见图 13,工程断面布置图见图 14。

图 13 滑坡治理平面布置简图 Fig. 13 Schematic diagram of landslide control layout

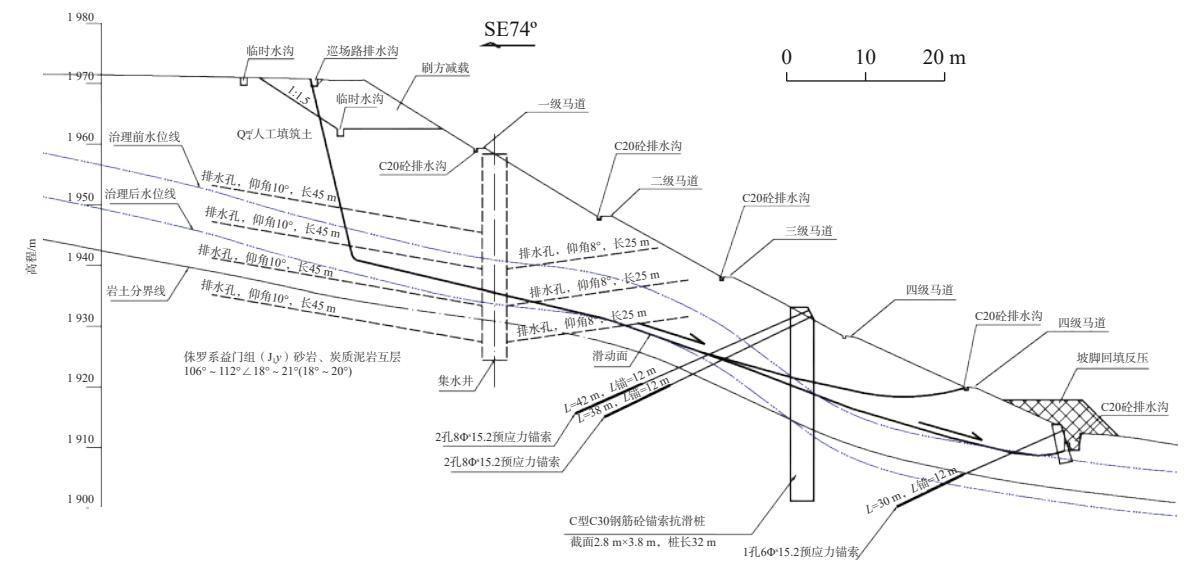
图 14 典型工程治理断面图

Fig. 14 The cross-section of typical engineering governance

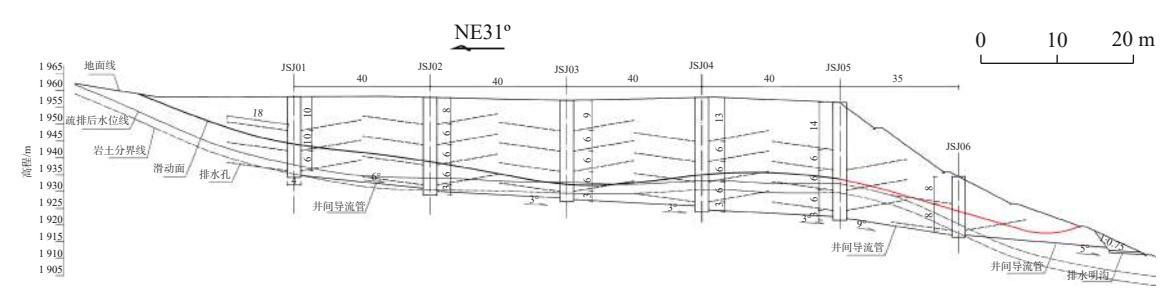
具体集水井设置在一级马道围栏外坡面,设置6个 集水井,直径4m,采用C30钢筋砼浇筑。为加大集水井 疏排地下水的范围及能力,在井壁设置1~4排放射状 集水斜孔以疏排滑体中的地下水,将地下水引至集水井 内,然后通过井间导流管将水引至下一个集水井,最终 将坡体中地下水排至滑坡体以外。具体集水井设置见 图15。

图 15 集水井横断面布置图

Fig. 15 The cross section layout of water collection wells

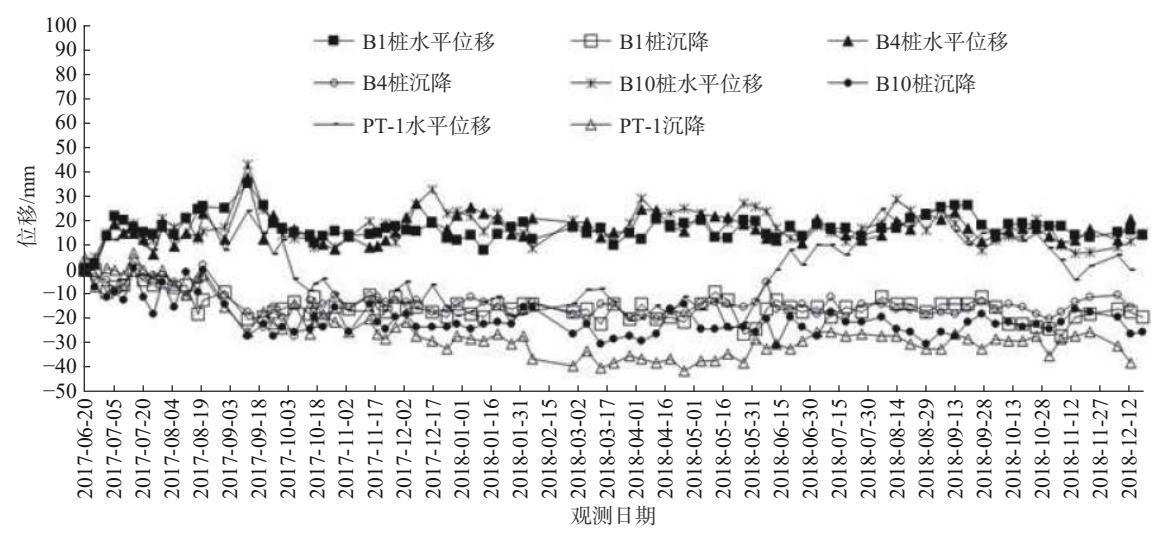
该滑坡应急治理及永久治理工程实施后,对其稳定 性进行了综合评估与长期位移监测,综合评估结果见 表1,长期位移监测见图 16。由表1可知,该滑坡体采 用支挡与排水并重的方式治理后,坡体处于稳定状态。 排水工程的实施,使得坡体中地下水及时疏排与水位降 低且雨季不再,保证了岩土体抗剪强度不衰减,有利于 坡体的长期稳定。由图 16 可知,治理工程实施后,坡体

位移无增大趋势,水平位移及沉降曲线均呈水平状,坡 体处于稳定状态。

图 16 累计位移(沉降)—时间曲线

Fig. 16 Accumulated displacement (settlement) - date curve

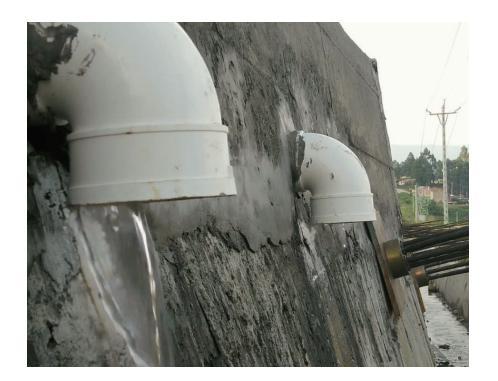
为评价集水井联合仰斜排水孔排水效果,在两个排水口(图17)进行了出水量监测。图18、19为两个排水

图 17 集水井出水口(左:出水口1;右:出水口2) Fig. 17 The collection well outlet (left: water outlet 1; right: water outlet 2)

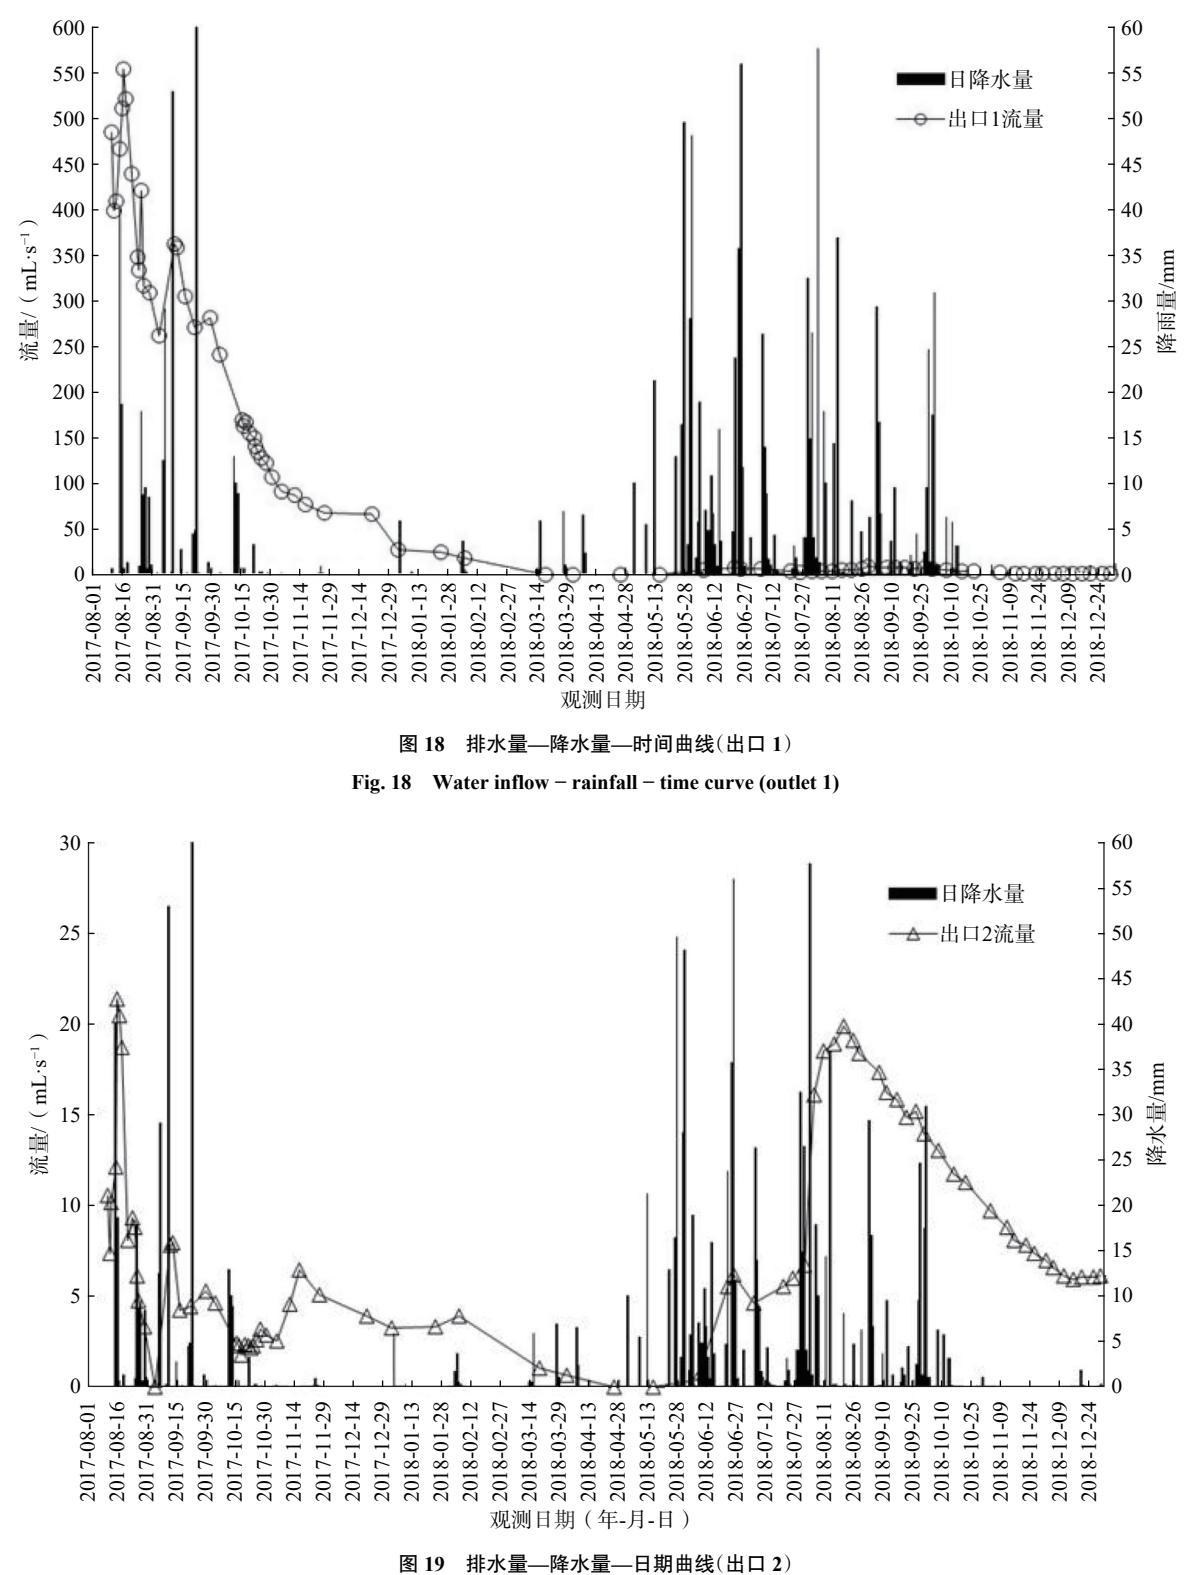
图 18 为出水口 1 涌水量—降水量—时间曲线。分析 表明, 排水初期, 由于为雨季, 降水量较大, 涌水量较大, 在 250~500 mL/s。2017 年 10 月后随着降水量的锐减, 涌水量也呈迅速下降趋势, 涌水量基本小于 50 mL/s。 2018 年进入雨季后, 降水量增多, 但出水口 1 涌水量没 有明显的增加, 基本稳定在 10 mL/s。图 19 为出水口 2 涌水量—降水量—时间曲线。分析表明, 出水口 2 涌 水量基本随降水量变化而变化。表现为, 降水量大, 涌 水量大,降水量小,涌水量小。但排水口2总体涌水量 没有排水口1大。综合比较可以得出,排水初期,坡体 内长期蓄存的地下水,基本通过排水口1在近两个月 的时间排出,2018年1月后,两个排水口基本响应了大 气降雨,及时排走了坡体内下渗的地下水。
